No. 92-13

A. LEAKAGE BETWEEN EXHAUST PIPE AND GIMBAL HOUSING ASSEMBLY

All stern drive models using **Through Prop Exhaust**. This includes all serial numbers.

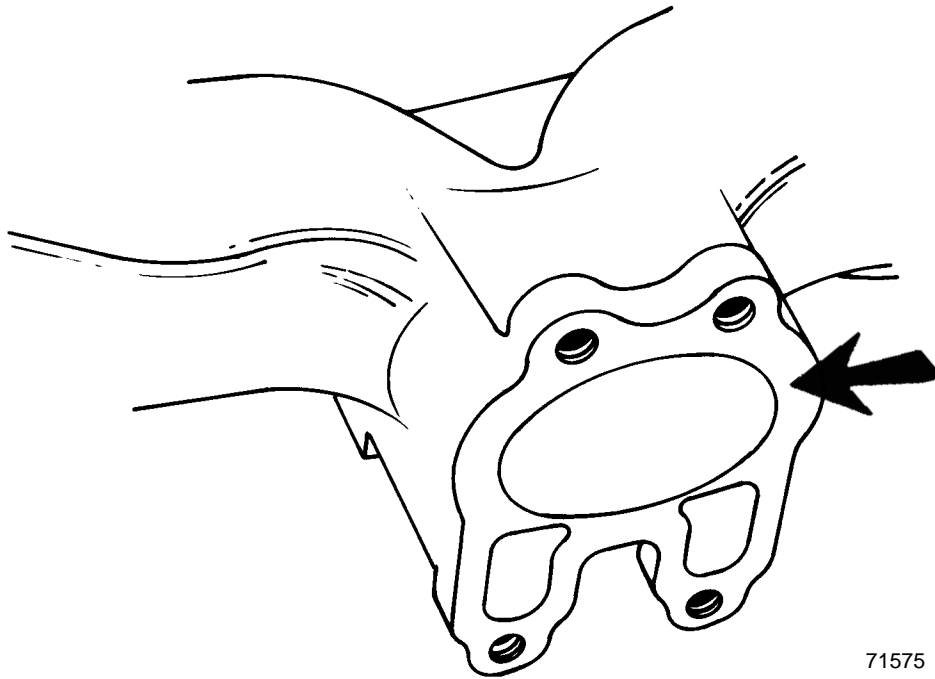
71575

Paint build-up on mating surface of the exhaust pipe can prevent proper sealing of the exhaust pipe to the gimbal housing assembly. A poor seal may result in water and / or exhaust leaking into the engine compartment or bilge of the boat.

Check mating surface of the exhaust pipe (shown below) for paint runs ect. If an irregular surface is found due to paint build-up, Any paint runs on the flange surface at the exhaust pipe should be sanded off so the flange is smooth and will seal properly.
