**No. 94-14**

## A. WIRING MODIFICATION

MCM / MIE D3.0L Serial Number 0D725223 - 0D725288  
MCM / MIE D3.6L Serial Number 0D850333 - 0D850454  
MCM / MIE D4.2L Serial Number 0D555036 - 0D319255

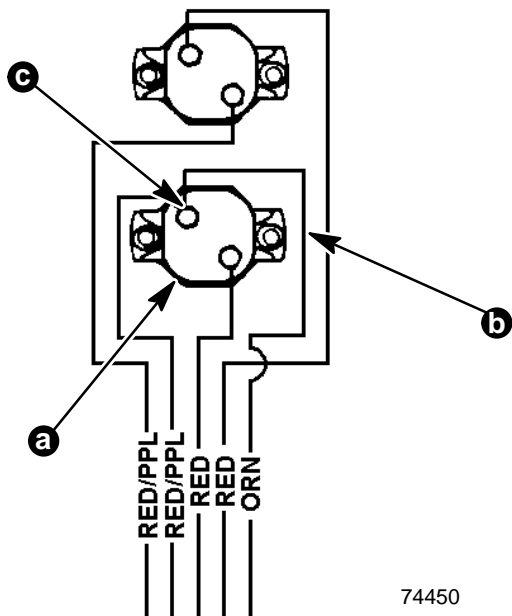
**Existing Connection**

The above model engines in the serial groups indicated are equipped with Mando alternators. These models have the alternator output lead wired through the 60 amp circuit breaker. The output of some of the alternators may cause the circuit breaker to trip causing premature failure of the voltage regulator or other electrical components.

Go to 60 amp circuit breaker with the ORANGE alternator output lead attached to it. Move the ORANGE wire from the connection with the RED/PURPLE wire, to the connection with the RED wire. See diagram below.

**NOTE:** Coat all connections with Quicksilver Liquid Neoprene after Modification.
