No. 95-10

MerCruiser MCM D7.3L/270 Diesel Stern Drive Replacement

Models

MCM D7.3L/270 MerCruiser Diesels

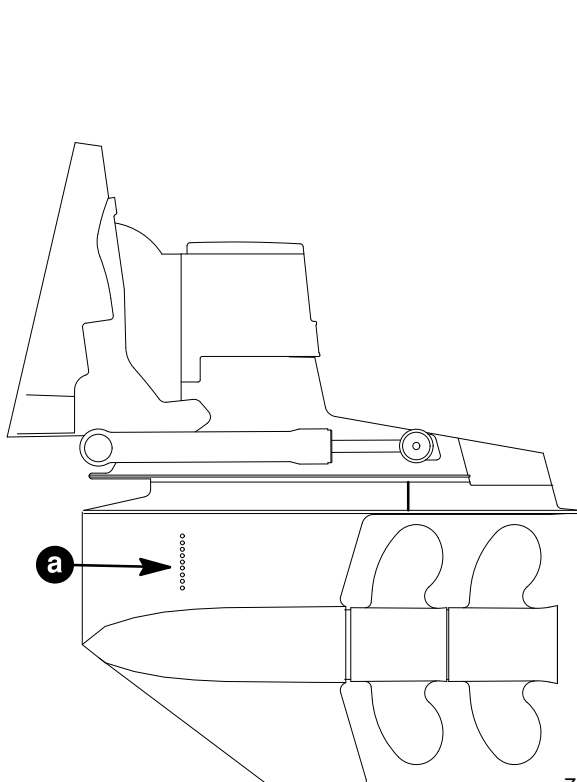
74716

An overheat situation could develop if the D7.3L/270 diesel model engines are mated with a 1996 Bravo Three.

a - Water Intake - 9 holes 94-95 M.Y.

If replacing a 1994 or 1995 Bravo Three with a 1996 Bravo Three (all gear ratios) a thru hull water pick up kit (P/N 88845A2) is required to supply adequate water flow to the engine. The 1996 Bravo Three has an 8 hole water pick up, whereas the 1994 and 1995 Bravo Three had a 9 hole water pick up.

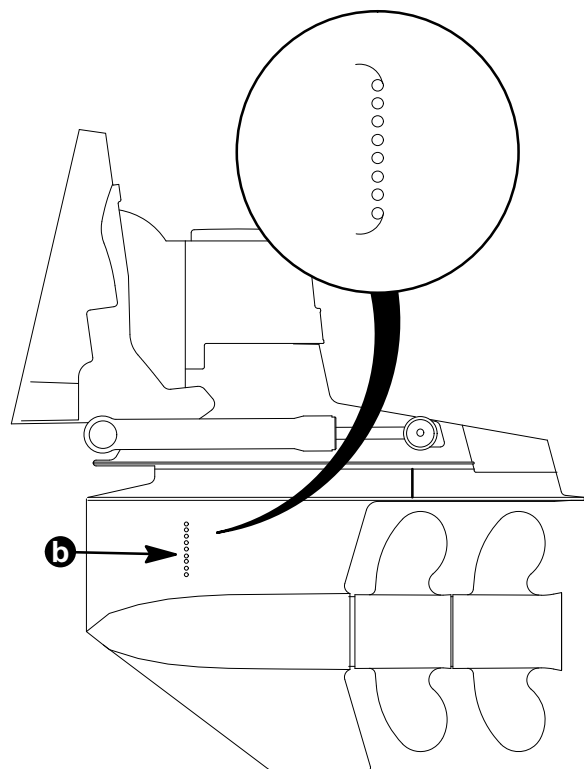
74717

b - Water Intake - 8 holes 1996 M.Y.
