No. 97-1

Torquing Intake Manifold on Gen+ Engines

All V6 and V8 Gen+ Engines.

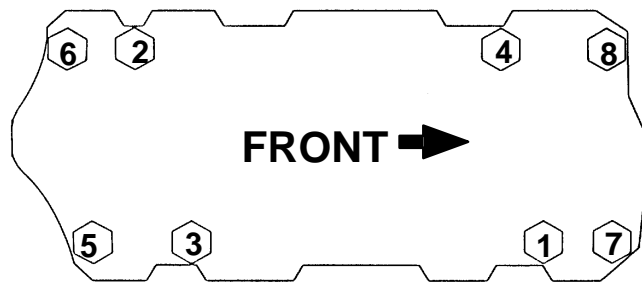
72878

The intake manifold on all Gen+ engines use a special torquing procedure. The following procedure must be used whenever an intake manifold is installed. Failure to follow this procedure could cause the intake manifold gasket to leak coolant into the oil or on top of manifold.

Torque intake manifold bolts in 3 steps and in sequence shown below.

1. 27 lb. in. (3 N.m).
2. 106 lb. in. (12 N.m).
3. 133 lb. in. (15 N.m).
