MerCruiser

Bulletin No. 2002-04

▲Required 496/8.1S Water Rail Parts Replacement

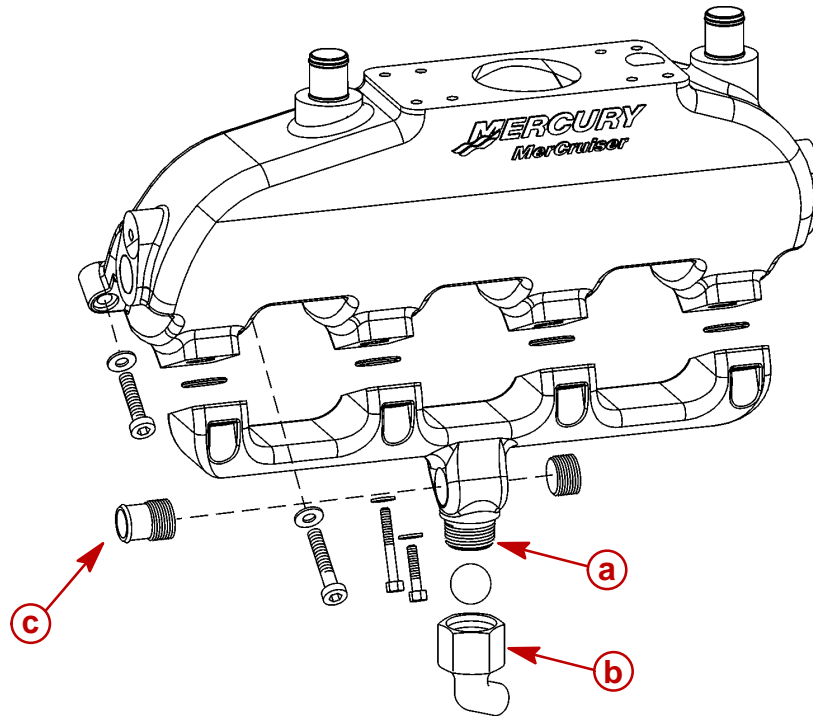
2. Inspect the threaded snout of the water rail and the hole in the water rail that held the hose bib fitting for severe damage due to corrosion.
 - On the water rail snout, severe corrosion damage is defined as damage that extends all the way around the snout or more than 1 full thread deep at any one location on either water rail snout.
 - In the hole for the hose bib fitting, severe corrosion damage is defined as damage that leaves less than 3 full undamaged threads.
3. Based on the results of your inspection, proceed as follows:
 - No severe damage found – Water rails should continue to be used. The water rail connector and the brass hose bib fitting must be replaced on both water rails on the engine. Order one Water Rail Connector & Fitting Kit per engine.
 - Severe damage present – Both water rails must be replaced. Order one Water Rail Replacement Kit per engine.

- a** - Water Rail Snout
- b** - Water Rail Connector
- c** - Hose Bib Fitting

Qty 1	P/N 863116A1	Water Rail Connector & Fitting Kit
Qty 1	P/N 862992A1	Water Rail Replacement Kit
