# MERCURY Service bulletin

✓ WARRANTY INFORMAT □ PARTS INFORMATION	ION 🗌 SEI	RVICE INFORMATIO	DN Bul	lletin No. 2002-03
Circulate to: Sales Manager	Accounting	Service Manager	Technician	Parts Manager

## **Required Boost Pump Installation**

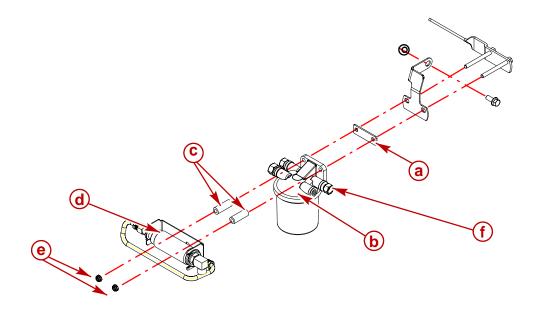
- a Insulator Plate
- **b** Fuel Filter Base
- c Collars
- d Boost Pump Assembly
- e Locknuts
- f Fuel Inlet Fitting

Before ordering the Boost Pump Kit, look at the engine to see if one has already been installed. The boost pump mounts to the fuel filter base. This kit includes an In-line Fuel Filter that is mounted between the boat's fuel tank and boost pump inlet. Follow the instructions supplied in the kit, mounting filter to the engine or boat's structure with the clip provided in the kit. Do not let the filter hang by hose connections or off of the fuel pump inlet.

IMPORTANT: Do not mount the In-line Filter Kit directly to the inlet of the Boost Pump. Per CFR 183.570, Fuel Filters and strainers: Installation (Code of Federal Registry - USCG). "Each fuel filter and strainer must be supported on the engine or the boat structure independent from its fuel line connections, unless the fuel filter or strainer is inside a fuel tank."
