OFFICIAL RECALL NOTIFICATION U.S. FEDERAL BOAT SAFETY ACT - SHIFT LINK BAR CONTACT WITH THE BACK COVER OF BRAVO X / XR DRIVES

Model	Serial Number Range
Bravo X I / II / III Drives	0W250000 through 0W266345
Bravo XR I / III Drives	0W240000 through 0W240652

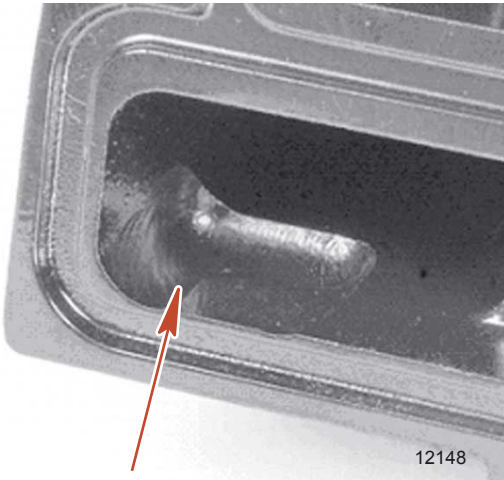
New cover with added link bar clearance

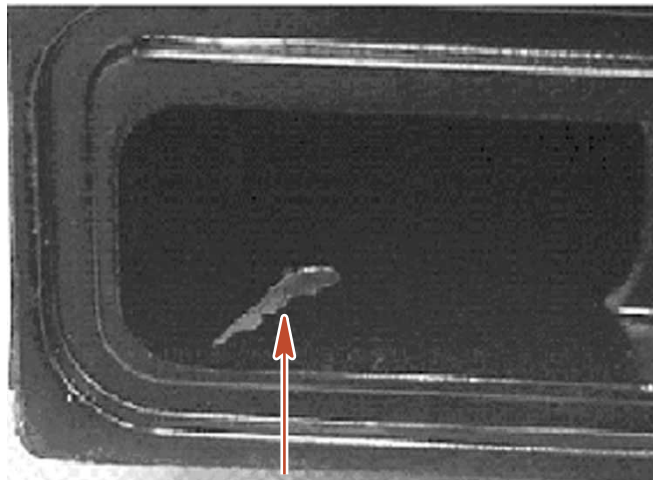
The shift link bar at the shift lever is making contact with the back cover of the drive shaft housing. The contact may cause the cotter pin to wear through, allowing the link bar to become disengaged from the shift lever, resulting in loss of shifting control. In right-hand rotation models it is also possible that the cone clutch could be prevented from engaging properly into the gear socket, resulting in the cone clutch being stuck in gear.

Contact area from link bar

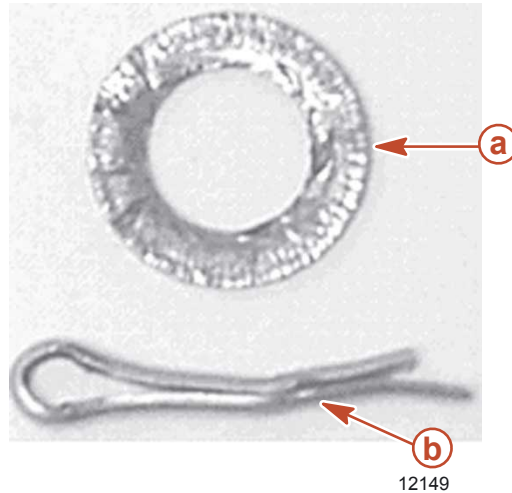
If the drive unit has been operated 30 hours or more, inspect the washer on the link bar for indentation marks from the cotter pin. If there are indentation marks on the washer, change both the washer and the cotter pin before installing the new rear cover.

a - Area of indentation marks on the link bar washer **b** - Wear area on the link bar cotter pin

1. Remove the back cover of the drive unit. Examine the shift link bar and cotter pin area, as well as the inside of the cover. The washer and cotter pin must also be inspected for any indentation marks on the washer from the cotter pin caused by heavy contact.
2. Replace the washer and/or cotter pin if there are indentation marks on either, then install the new back cover and seal from the replacement back cover kit. Using Special Lubricant 101, lightly grease the new detent ball canister and spring assembly and place it into the new back cover before installation.

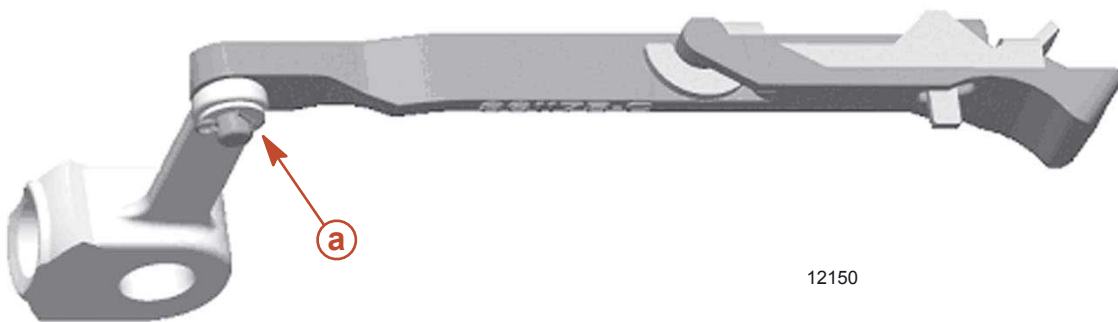
a - Washer and cotter pin
