Gruppe	Nummer	Version
B 0.3	smc-07-84 vwm-07-04	01

Adjustment of exhaust turbocharger for Red-Diesel

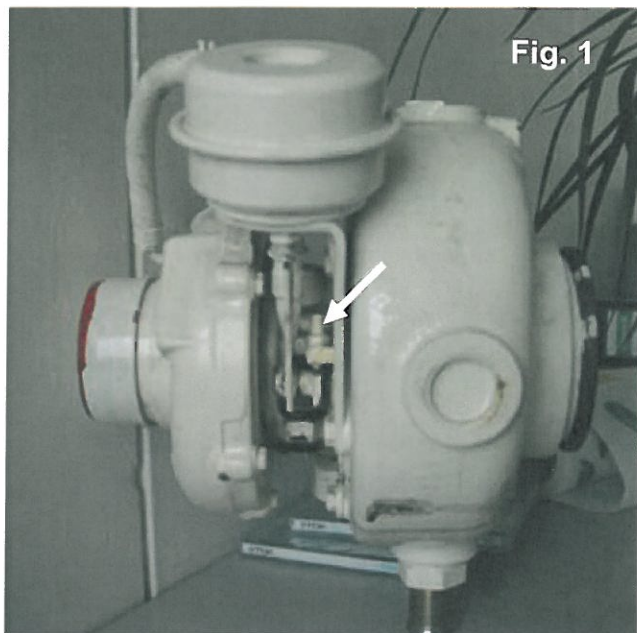
Fig. 1

Using Red-Diesel (tax-exempt fuel) leads to higher ignition delays and thus to increasing soot because of lower cetane number.

Partially that soot is as powerful, that the guide vane pitch device of the turbocharger gets blocked.

In bad case an increased boost pressure will be generated on full load, which again generates an error entry and thus the flashing of the system lamp.

In order to suppress the flashing of the system lamp, the set screw at the adjusting bar of the turbocharger (arrowed in Fig.1 and 2.) can be adjusted by turning it clockwise 3 x 360° and additionally by 210° (= 3 ¾ rotations).

The sooting of the engine will not be stopped by this, but the error entry will be eliminated.
