Service Bulletin

Bulletin No. 2013-70 OEM No. 2013-68
Circulate to:	Sales Manager	Accounting	Service Manager	Technician	Parts Manager

Zeus Pod Interface Ring Inspection Criteria

Models Covered
All Zeus 3000 Series Pods

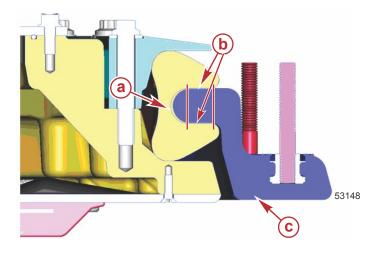
Sealing surfaces: As shown below, the grommet seals on the top and bottom surfaces of the interface ring when the clamp load is applied. The inside radius has clearance and does not provide any sealing benefits.

Surface imperfections: Surface imperfections are often noted on the interface ring inside edges of the bullnose radius due to the manufacturing cleanup and flash removal process. In addition, sealing surface imperfections may consist of craters or voids caused by the extreme high glass content and vinyl ester material.

- a Bullnose inside radius
- Bullnose sealing surfaces approximately 15.2 mm (0.6 in.)
- c Interface ring

Sealing surface visual inspection: Visually inspect the interface ring top and bottom sealing surfaces as shown in View 1 above. These areas should be free of any material flaws or defects that span across the entire surface. (Note that ejector pin marks are not considered flaws or defects.) Periodically there may be conditions on the ring surfaces which may have minor craters or voids which can be rough in appearance, caused by the extreme high glass content and vinyl ester material. As long as these blemishes are minor in depth and do not span across the entire sealing surface, these conditions will not affect the integrity of the part. Acceptable surface imperfections are shown in View 2 below.

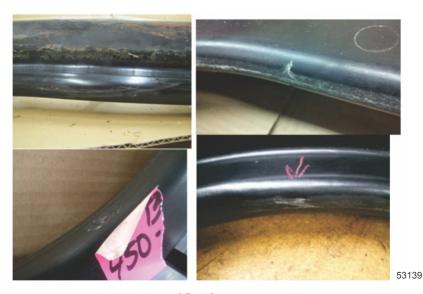
Inside radius visual inspection: Visually inspect the interface ring inside radius as shown previously in View 1. This area can have minor material nicks or flaws, due to the manufacturing cleanup and flash removal process. Acceptable flaws are shown in View 3 below.

Acceptable interface ring: When field repair is being performed and any flaws similar to those shown above are noticed, there is no reason to replace the interface ring.

Uncertain if acceptable: If unsure, please take close-up pictures of suspect area and forward to Mercury Diesel Product Support for review.
