## Possible Water Passage Restriction on Bravo Drives

Models Covered	Serial Number
All Bravo I, Bravo II, and Bravo III. Standard, X and XR Sterndrives	2A002278-2A112618

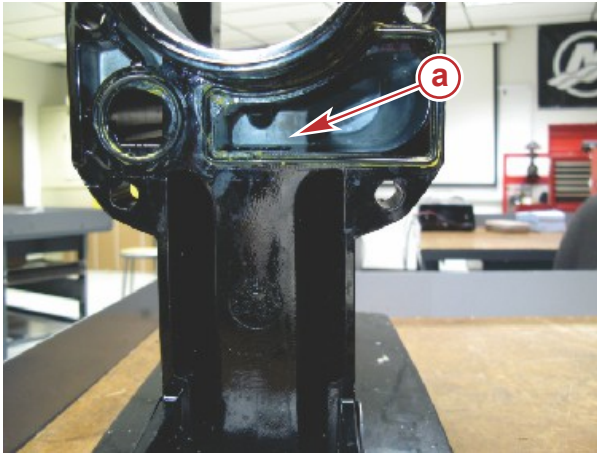
52778

There have been reports of a water passage in the Bravo driveshaft housing being cast over. This condition will not allow cooling water to flow to the engine. This material, known as casting flash, is normally trimmed away prior to finish painting of the driveshaft housing. When the casting flash is trimmed from the water passage, there is also a chance for it to remain partially attached or stuck in the water passage.

**a** - Inspect this water cavity

OEMs will need to inspect their inventory of loose drives for the blocked passageway or for the presence of residual flashing. If the passageway is cast over, do not attempt to clear the passage. Replacement of the drive will be necessary. If the flashing is partially attached or stuck in the water passage, remove the flashing and use the drive as normal.

Dealers will need to inspect their inventory of loose drives for the blocked passageway or for the presence of residual flashing. If the passageway is cast over, replacement of the drive will be necessary. If the flashing is partially attached or stuck in the water passage, remove the flashing and use the drive as normal.

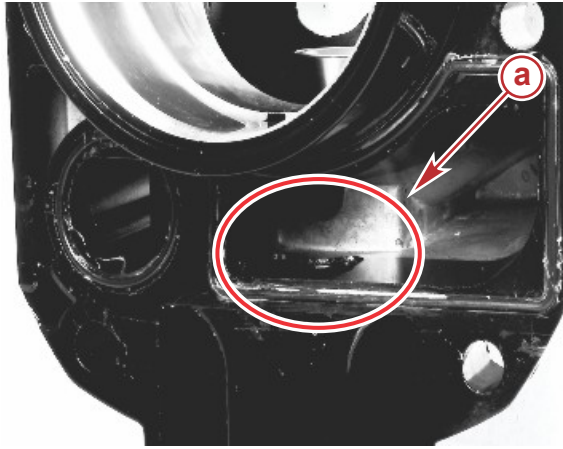
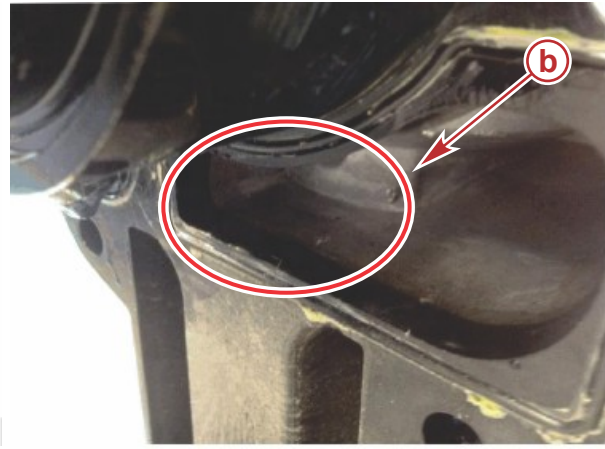
52779

- a - Properly trimmed water passage
- b - Castover water passage

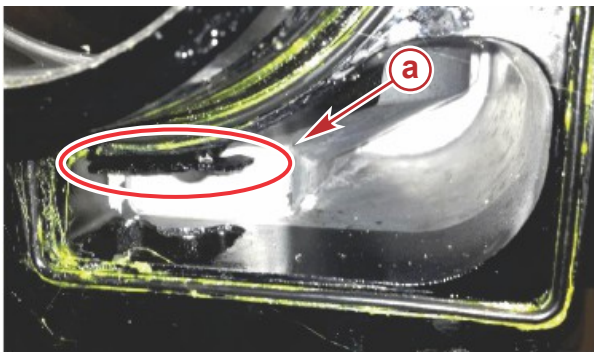
52803

- a - Casting flash stuck in water cavity
