## 6 Inch Exhaust Riser Replacement

Models Covered	Serial Number Or Year
ECT 5.0L, 350, 377, 5.7L, and 6.2L engine models for Sterndrive, Inboard, and TowSport	2A437183 and below

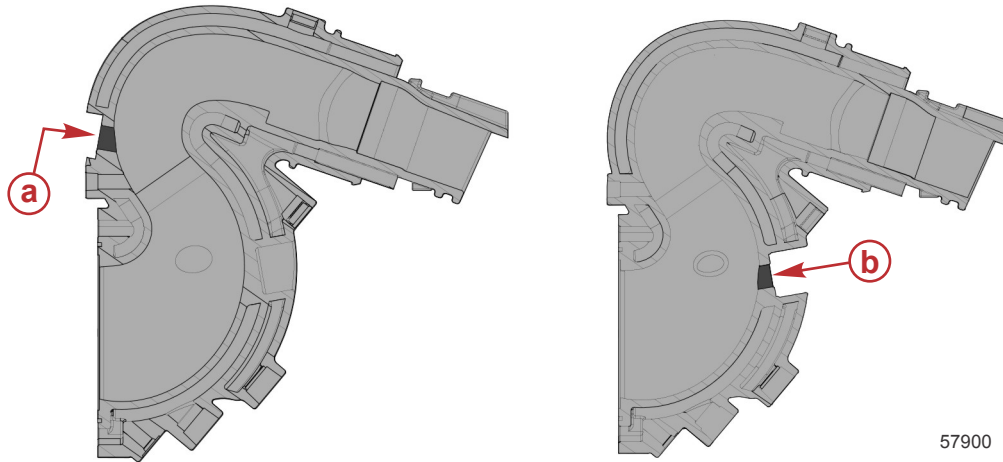
## 6 Inch Exhaust Riser Comparison

The following image shows the difference between the new style and old style exhaust risers. This will act as a quick visual for the technician when inspecting the engine for repeat post O2 sensor failures. Engines with the new style exhaust risers will not have to be checked for repeat post O2 sensor failures.

- a** - New style exhaust riser post O2 sensor location
- b** - Old style exhaust riser post O2 sensor location

The engines listed under **Models Affected** will need to have their history checked for repeat post O2 sensor failures. The engines that have been identified with repeat post O2 sensor failures will need to have the 6 inch exhaust risers replaced with the new exhaust riser kit (8M0094682).
