4.5L Sterndrive Engine Flame Arrestor Clamp

Models Affected

| Models Covered | Serial Number Or Year |
|---|---|
| All Sterndrive 4.5L Engines | 2A441953–2A446695 |

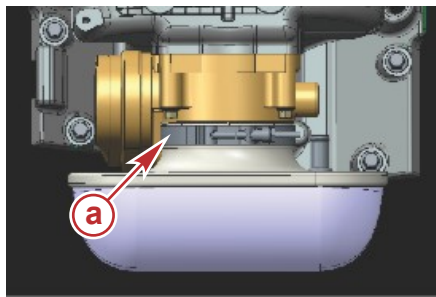
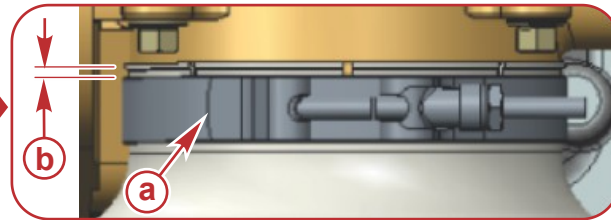
57543

- The clamp adjusting mechanism should be at the 12 o'clock location.
- Ensure that the clamp covers the fingers of the flame arrestor and maintains a gap between the lip on the flame arrestor and the edge of the clamp of 0–3 mm (0–0.118 in.).

IMPORTANT: Ensure that the gap is uniform all the way around the flame arrestor.

- a - Clamp
b - The gap between the lip on the flame arrestor and the edge of the clamp

2. Inspect the flame arrestor and clamp position using the location requirements pictured below and reposition as necessary.

3. Tighten the clamp nut to the specified torque even if you did not have to reposition the clamp.

| Description | Nm | lb-in. | lb-ft |
|---|---|---|---|
| Flame arrestor clamp nut | 6.2 | 55 | – |
