## Possible Water Passage Restriction on Bravo Drives

| Models Covered | Serial Number |
|---|---|
| All Bravo 1, Bravo 2, and Bravo 3. Standard, X, and XR Sterndrives. | 2A338483–2A342849 |

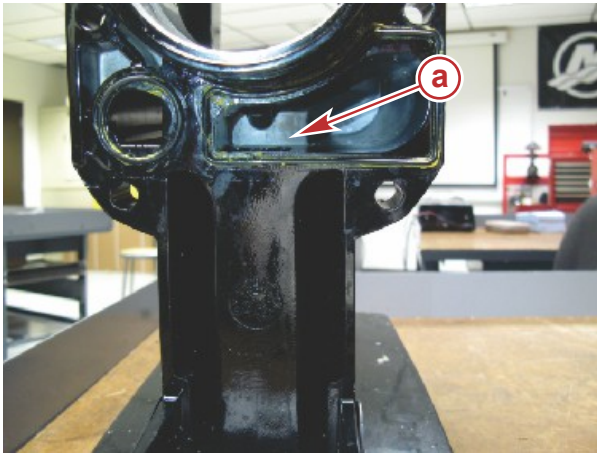
52778

There have been reports of a water passage in the Bravo driveshaft housing being cast over. This condition will not allow cooling water to flow to the engine. This material, known as casting flash, is normally trimmed away prior to finish painting of the driveshaft housing. When the casting flash is trimmed from the water passage, there is also a chance for it to remain partially attached or stuck in the water passage.

**a** - Inspect this water cavity

OEMs will need to inspect their inventory of loose drives for the blocked passageway or for the presence of residual flashing. If the passageway is cast over, do not attempt to clear the passage. Replacement of the drive will be necessary. If the flashing is partially attached or stuck in the water passage, remove the flashing and use the drive as normal.

Dealers will need to inspect their inventory of loose drives for the blocked passageway or for the presence of residual flashing. If the passageway is cast over, replacement of the drive will be necessary. If the flashing is partially attached or stuck in the water passage, remove the flashing and use the drive as normal.

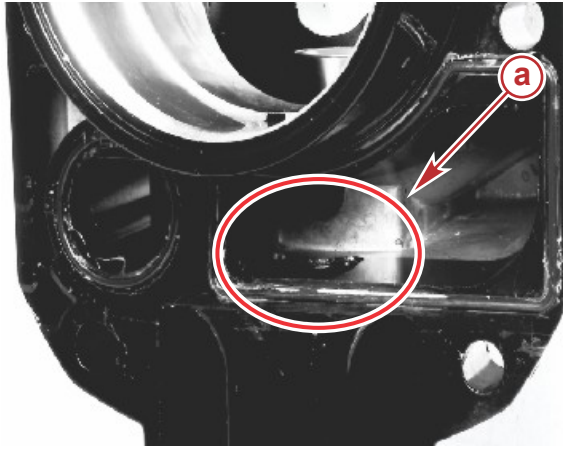
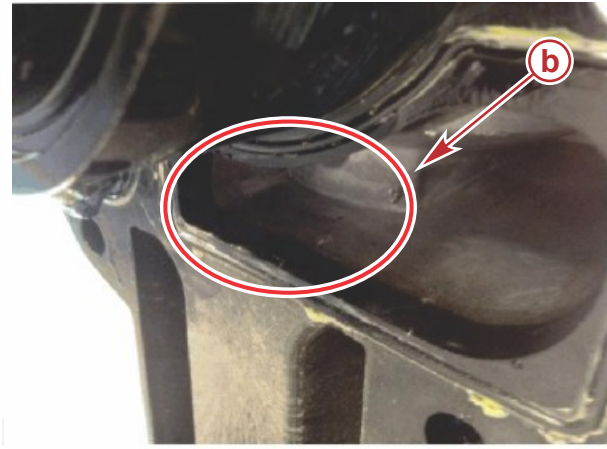
52779

- a - Properly trimmed water passage
- b - Cast over water passage

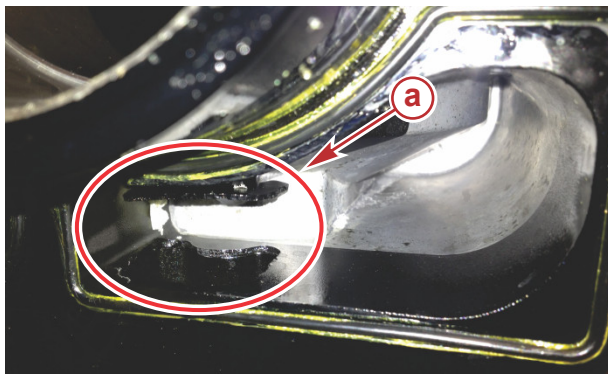
63327

- a - Casting flash stuck in water cavity
