MerCruiser Guardian Low Water Pressure Fault

Models Affected

| Models Covered | Serial Number Or Year |
|---|---|
| 4.3L MPI RWC EC Alpha models | 1A645142 and above |

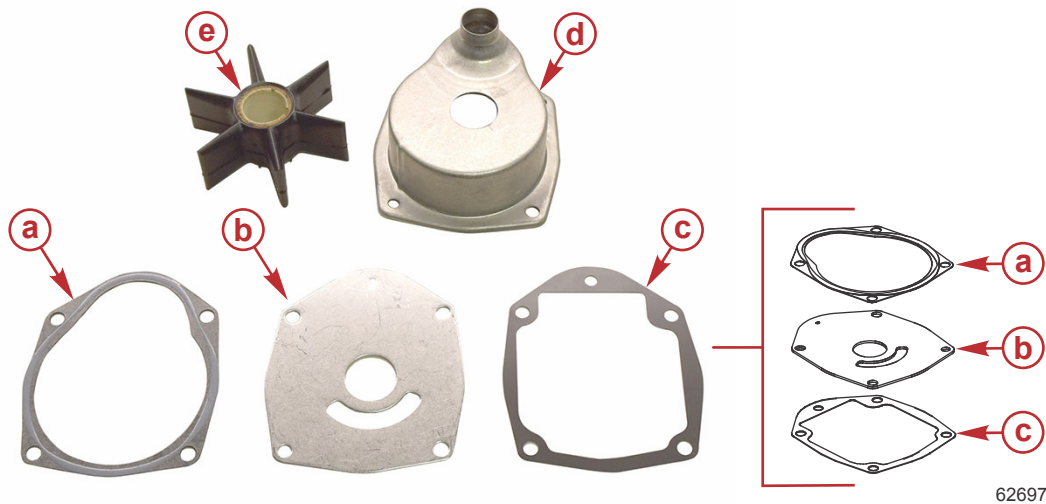
Current water pump kit

- a - Fiber gasket with neoprene bead
- b - Faceplate
- c - Metal gasket
- d - Water pump cover
- e - Impeller

6. Replace the sterndrive water pump components with an appropriate complete water pump kit. The rubber overmolded faceplate must be replaced with a metal faceplate without rubber. Refer to the illustration below for the proper installation sequence of the faceplate and gaskets.

NOTE: Ensure you have a current water pump kit without the overmolded faceplate. It is not acceptable to reinstall kits that contain an overmolded faceplate.

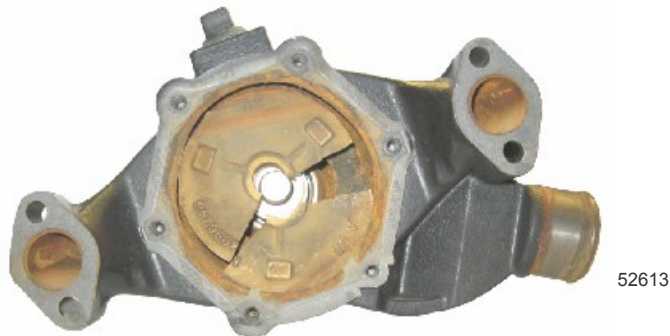
Cracked circulation pump impeller

7. Inspect the circulation pump impeller for cracking. Refer to **MerCruiser Service Bulletin 2013-05** for inspection and correction information.
