Official Recall Notification U.S. Federal Boat Safety Act

Volkswagen Marine 3.0L TDI Tier II Ultraflex Control System Replacement and Turbocharger Oil Supply Line Sealing Washers

Reference Mercury Diesel Service Bulletin 2017-63

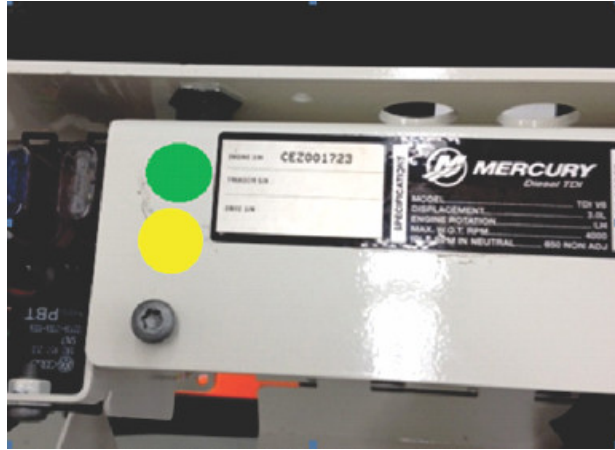
62628

Engines that have the oil sealing washers reworked by the factory or by an authorized dealer will have a mark indicating that the rework has been performed. With the engine removed from the shipping container, or installed in a boat, the rework identification will be a yellow dot placed to the left of the serial number decal.

NOTE: A green dot may also be found. The green dot indicates that the oil supply line has already been updated. If a green dot is not found, please refer to **Mercury Diesel Service Bulletin 2014-68**.

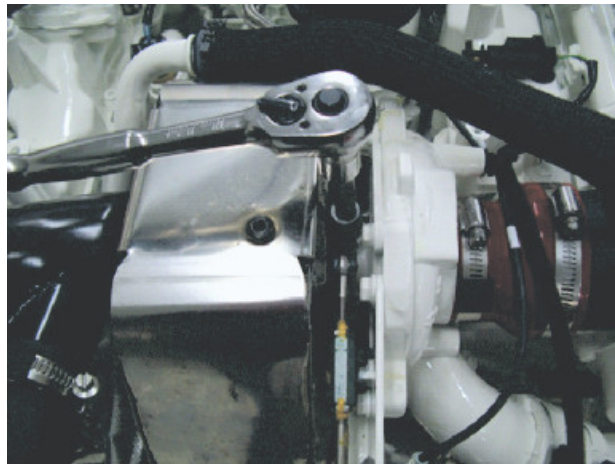
62629

Oil supply line hollow bolt

1. Remove the engine cover.
2. Remove the hollow bolt securing the oil supply line to the turbocharger.

3. Remove the sealing washers on each side of the hollow bolt fitting.

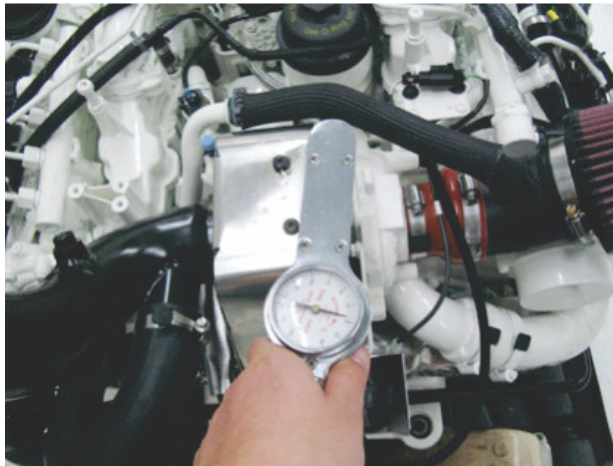
62631

Proper torque

5. Tighten the hollow bolt to the specified torque.

Description	Nm	lb-in.	lb-ft
Hollow bolt	20	177	–

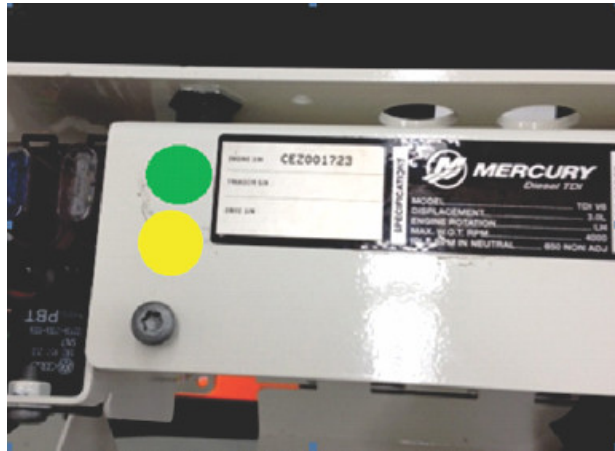
62628

Yellow dot location

- Affix a yellow dot next to the serial number decal to indicate that the rework has been performed.
