## Rocker Arm Replacement Required

Models Covered	Serial Number Or Year
8.2L EC and Non-EC Sterndrive and Inboard	Refer to the <b>Serial Numbers Affected</b> table at the end of this bulletin.

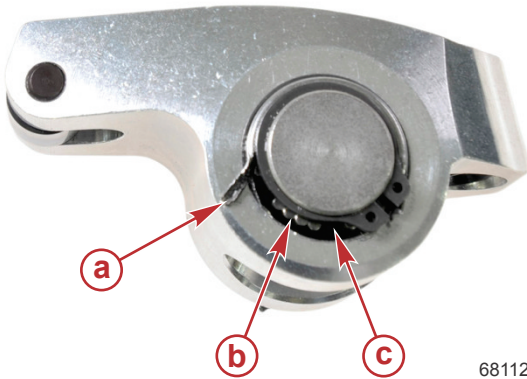
### Damaged rocker arm

Inspect for evidence of rocker arm damage before and during removal of the rocker arms. Look for loose needles and cage breakouts on the head surface and near the springs and rocker arms. Check both intake (top) and exhaust (bottom) areas. Any indication of material loss (missing cage material or needles) will result in the need to replace the longblock.

- a** - Cage material damaged/missing
- b** - Exposed needles
- c** - Missing needles

- If evidence of rocker arm damage exists, order a new longblock (refer to **Parts Required, Longblock Replacement**). Refer to Service Manual 8M0081787, 8.2 Liter Gasoline Engine for replacement instructions.
