Removing Dielectric Grease

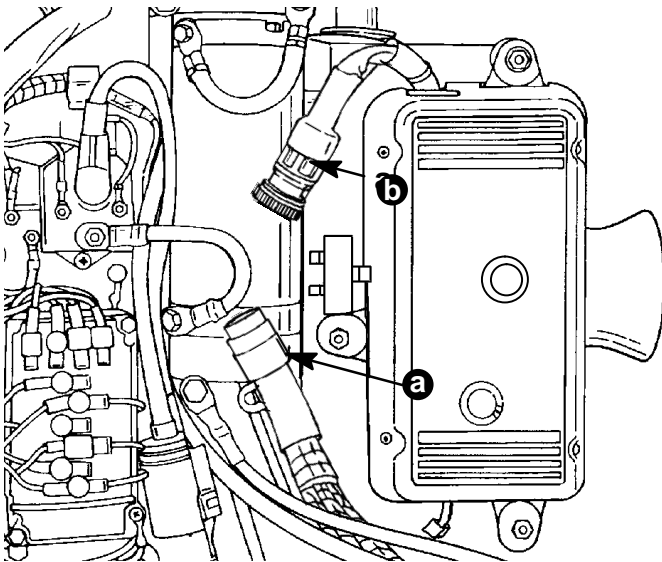
a - Engine Connector
b - ECU Connector

Mercury Hi-Performance has found that the use of Dielectric grease in the sixteen (16) pin ECU connector can affect adequate electrical contact for the power supply to the electric fuel pump. This applies to all 2.5L and 2.0L Hi-Performance EFI engines using a digital ECU box. Hi-Performance has discontinued the use of Dielectric grease on the ECU sixteen pin connector.

1. Disconnect ECU harness connector and clean terminal connections with paint remover (methylene chloride). Thoroughly dissolve and remove all dielectric grease. Spray connectors with a multi-purpose lubricant like CRC Power Lube or WD-40. Reconnect ECU harness.

IMPORTANT: Do not remove dielectric grease from any other connections.
