PERFORMANCE OUTBOARDS

service bulletin

No. 97-8

2.5 Cowl Trim Switch Installation

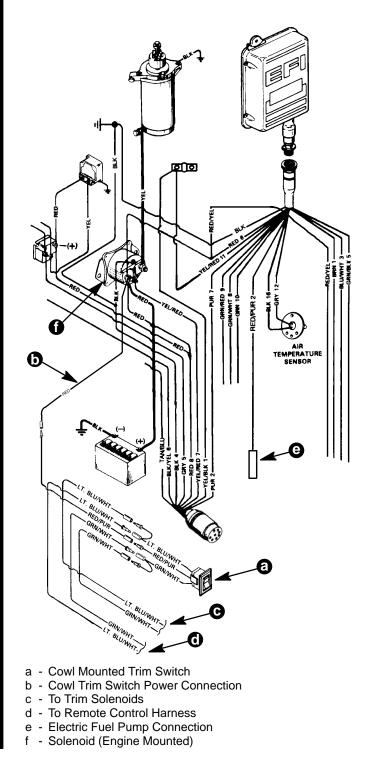
PROBLEM: INCORRECT TRIM SWITCH WIRING CONNECTIONS

IMPORTANT: The power source to operate the trim switch must come from the (+) red lead of the engine mounted solenoid. An existing Red/Purple wire (which is intended to be used for an electric fuel pump) extends from the EFI wiring harness connection on the engine. This lead CAN NOT be used as the power lead for the trim switch connection even though the color coding matches. If used, this connection may cause severe operating system damage to your outboard.

1. Connect the Red/Purple lead of the new Cowl Trim Switch to the Red lead terminal on the engine mounted solenoid.
