WARRANTY INFORMATION SERVICE INFORMATION

Vapor Separator Cover (VST) Fitting

Pro Max 200/225 HP,
S/N 0G857653 Thru 0G858175

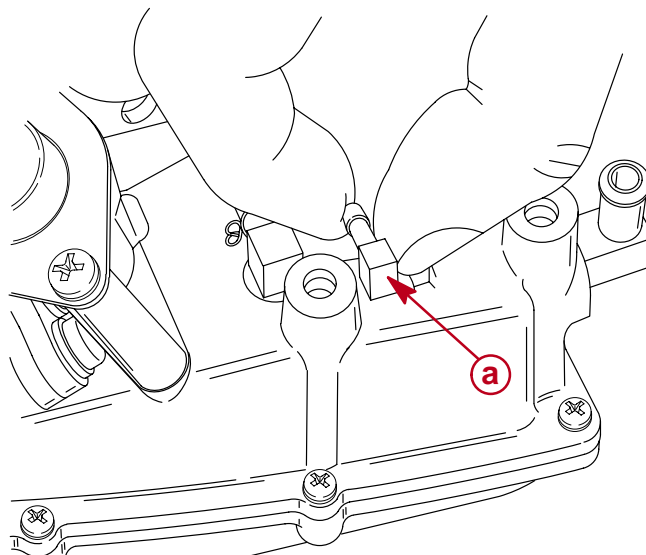
57753

If the outboard is within the above serial number range and does NOT have the factory rework markings on the engine carton or engine, check the fitting for tightness. Remove the bleed return hose from the fitting, and by hand using moderate pressure try to twist the fitting in the VST cover. If the fitting can be turned by hand, it should be replaced with fitting **P/N 22-877324**.

a - Elbow Fitting

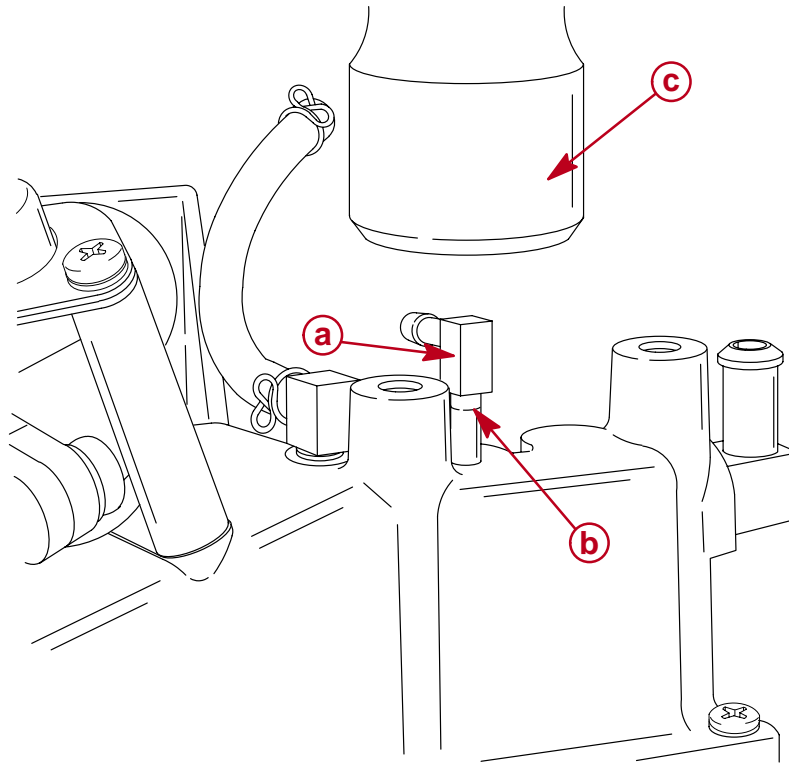
57754

- a** - Elbow fitting
- b** - Serrated portion
- c** - Hammer

If the fitting is found to be loose, remove the old fitting. Install new fitting **P/N 22-877324** by carefully using a hammer to drive it into the VST cover. The fitting should be installed with the serrated portion facing down toward the cover. Check the new fitting for tightness, reinstall the bleed line, and mark a WHITE dot on the side of the VST.
