300X Pro Max Service Gearcases

Modles Affected

All Mercury Racing 300X Pro Max engines S/N 0T235084 and below.

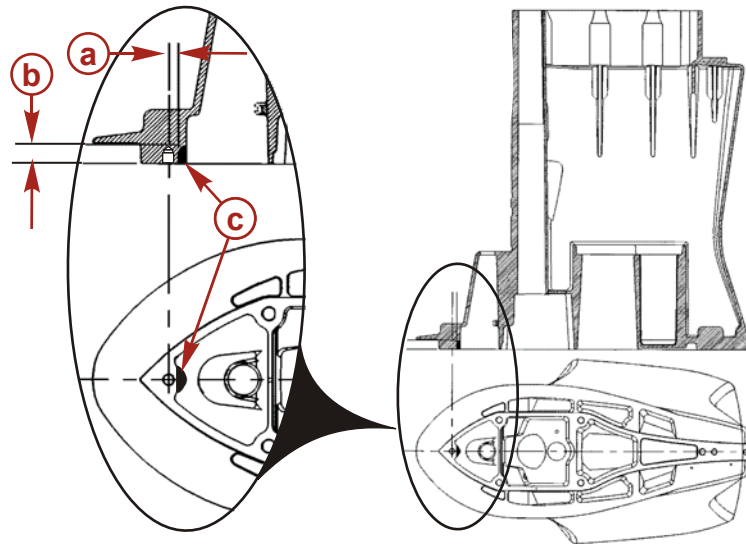
16393

Possible interference may occur between the driveshaft housing and shift shaft cover on dual inlet gearcase assemblies.

To ensure proper clearance, remove/grind the indicated material (shaded area) from the driveshaft housing.

- a** - Distance from centerline of forward dowel pin hole – 8.13 mm (0.320 in.)
- b** - Cutting depth – 15.75 mm (0.620 in.)
- c** - Material to be removed – Radius 6.35 mm (0.250 in.) maximum
