Service Bulletin

Outboard No. 2017-02R1

200XS, 250XS, 300XS, and DSI Air Compressor Reed Failure

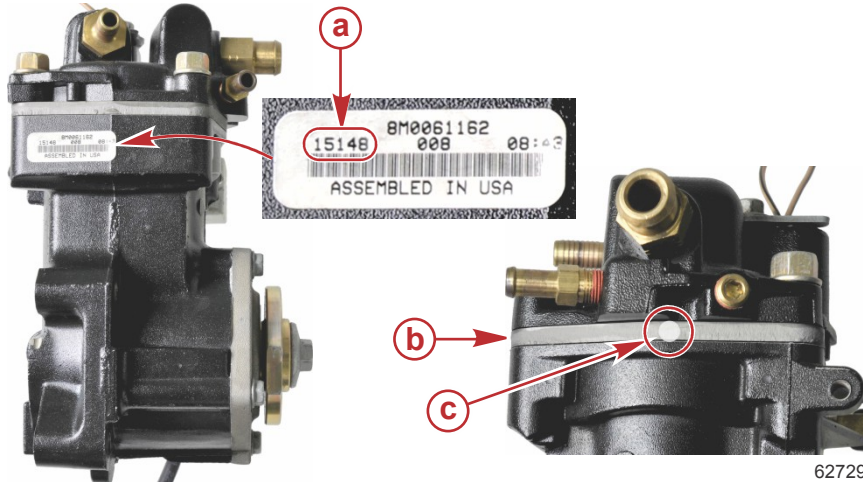
Air compressor

The 2.5L and 3.0L OptiMax air compressor reeds may fail prematurely due to incorrect reed material. This may result in a no start condition, poor running quality, or engine stalling.

- a - Julian date code; codes 14189 through 16246 are affected
- b - Reed plate assembly
- c - White dot indicating that the reed plate assembly has been replaced and is not affected

Inspect all in-stock replacement air compressors. If no white dot is present and the Julian date code falls between 14189 (July 8, 2014) and 16246 (September 2, 2016), inclusive, replace the reed plate assembly.

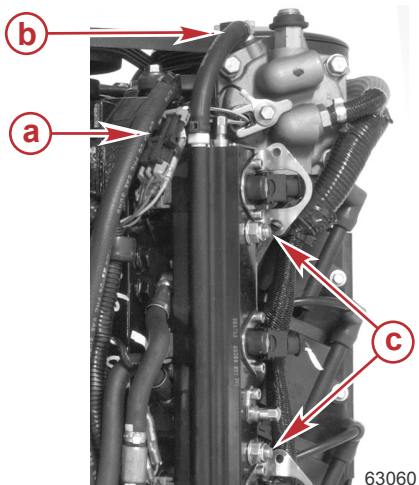
- a - Cylinder head temperature sensor harness connector
- b - Compressor water inlet hose
- c - Fuel rail mounting nuts (2)

1. Disconnect the cylinder head temperature sensor harness connector.
2. Disconnect the compressor water inlet hose.

3. Remove the two fuel rail mounting nuts.

4. Without removing the lower cowl, position the fuel rail out of the way, and complete the reed plate assembly replacement. Before putting the engine back into service, be certain to reconnect all items and tighten the fuel rail mounting nuts to the specified torque.

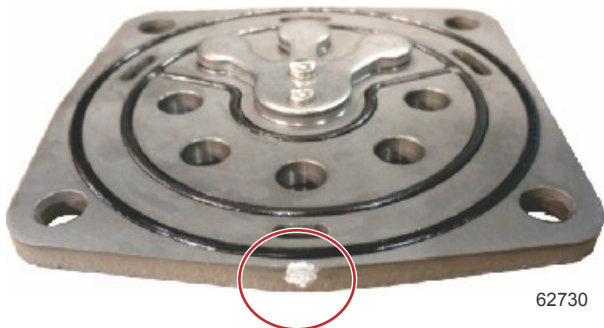
Reed plate assembly edge marked with a white dot

- To indicate that the rework procedure has been completed, mark the top edge of the replacement reed plate assembly with a white dot.
