## Official Notification - Federal Boat Safety Act Sport Jet 90

### 1993 and 1994 SPORT JET 90

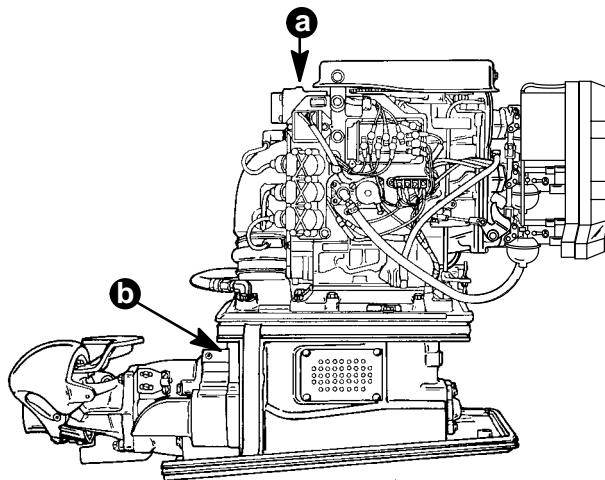
Sport Jet 90 units have two serial numbers. Please note that the serial number at the powerhead (a) is not the same as the pump (b). Sport Jet 90 units may have a field campaign involving both the powerhead and the pump.

a - Power Head Serial Number  
b - Jet Pump Serial Number

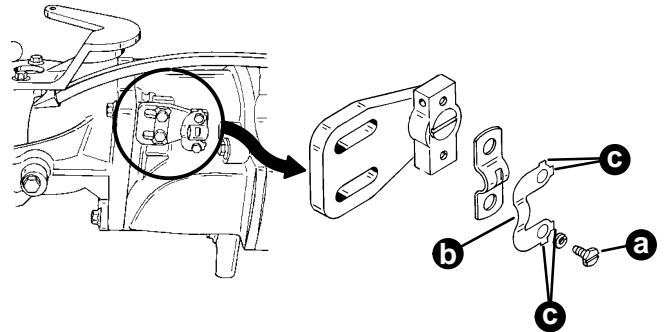
We have some reports of the shift cable clamp screws loosening. This condition can result in loss of shift control.

a - Screw (2)  
b - Tab Lock- Positioned Toward Reverse Gate  
c - Locking Tabs

1. Install a tab lock, p/n 14-820601, as shown in the figure below with radius portion (b) of the tab lock towards the reverse gate.
2. Torque screws (a) to 50 lb. in. (5.65 N-m).
3. Bend tabs (c) over flats of the screw head.

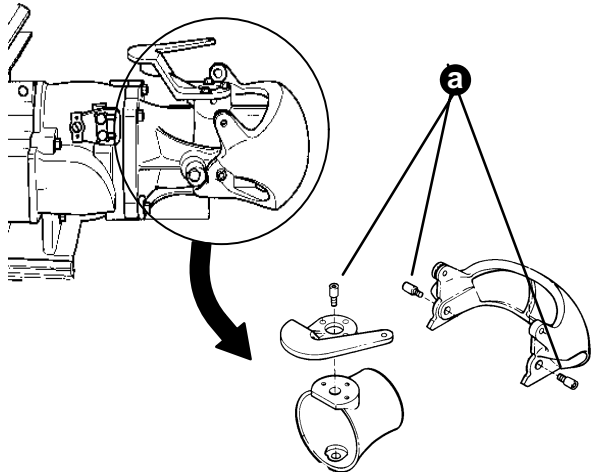
Loose reverse gate pivot bolts have been reported on some pumps. This condition can lead to loss of shift control.

a - Pivot Bolts (3)

1. Remove three pivot bolts (a) as shown in the figure following.

- Apply Loctite #271 (p/n 92-32609-1) to threads of the pivot bolts.
- Install pivot bolts (a) and torque to 25 lb. ft. (33.89 N·m).

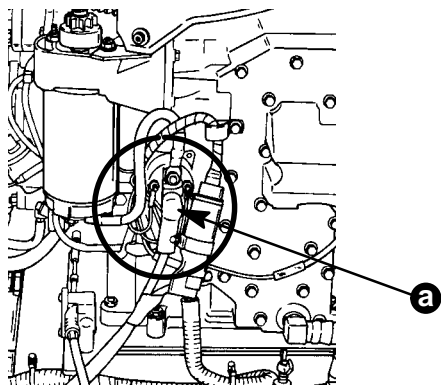
a - Boot, Positive Battery Terminal

The U.S. Coast Guard recently cited two boat builders who were in violation of regulation #33 CFR 183.445 (b) which requires that the “positive” battery cable connection at the starter solenoid terminal be protected by either a boot (a) or protective shield.

For the convenience of all parties (the consumer, dealer and boat builder), inspect the starter solenoid terminal connection with the “positive” battery cable to see if it is protected with a boot. If it is not, order the boot (p/n 85-79695) and install on the terminal connection of the “positive” battery cable and terminal of the starter solenoid.
