## Driveshaft Replacement 40/50

### Models Affected

1995 Force 40/50  
Serial Number  
US 0E123524 thru 0E135075

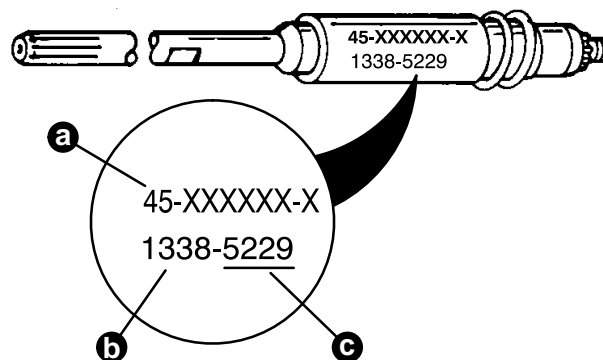
**Figure 1. Driveshaft Date Code**

The outboards listed may have driveshafts with defective welds. Endurance testing has discovered a small possibility of voids in the weld that joins the stainless steel upper section to the carbon steel lower section of the driveshaft. Operation of the outboard may result in early driveshaft failure.

- a - Driveshaft Part Number
- b - Manufacturing Number
- c - Date code

1. Remove gear housing and the driveshaft as outlined in the Outboard Service Manual.
2. Check the date code on the driveshaft per Figure 1.
3. Driveshaft **MUST BE** replaced if the date code is 5190 thru 5233.
4. Order Parts Kit p/n 809796A1 and driveshaft (if required) per this bulletin for reassembly.
5. Reassemble and install the gear housing as outlined in the Outboard Service Manual.
6. Fill the gear housing with Quicksilver gear lube, install the propeller, and check for proper operation of the outboard.

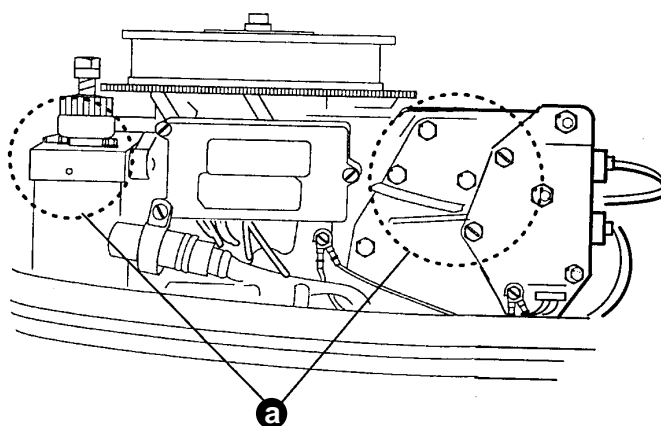
**Figure 2. 40/50HP Rework Marking**

- A red or black letter "D" hand applied with a marker on the outboard serial number label of the shipping carton.
- A yellow dot or marking painted on the powerhead (Figure 2).

- a - Yellow Paint Marking
