Exhaust Manifold Bolts - Sport Jet 120

MODELS AFFECTED:

1995 Sport Jet 120
S/N 0E093700 thru 0E125508

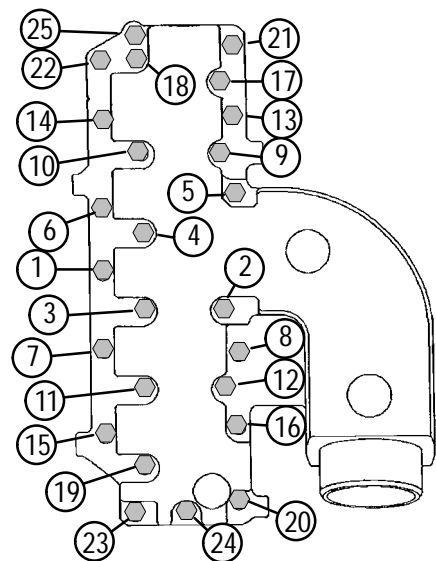
Figure 1

We are receiving sporadic reports from the field on Sport Jet 120's that have leaked water at cylinder and exhaust manifold parting line.

Investigation of this problem revealed reduced (low) clamp load on exhaust manifold gasket. This is caused by initial thermocycling of powerhead which reduced torque of stainless steel bolts.

NOTE: It is very important to oil bolt threads and underside of head prior to installation to achieve proper and uniform clamp load.

1. Remove bolt #1 per Figure 1. Install new bolt and existing washer. Torque bolt to 115 lb/in (13.0 N-m). Then, follow same procedure for bolt #2 and so on until all bolts have been replaced and torqued following the sequence in Figure 1.

2. After all bolts have been replaced and torqued, retorque bolts #1 thru #8 (center bolts) per Figure 1.
