Starter Motor Failures – All Sport Jet

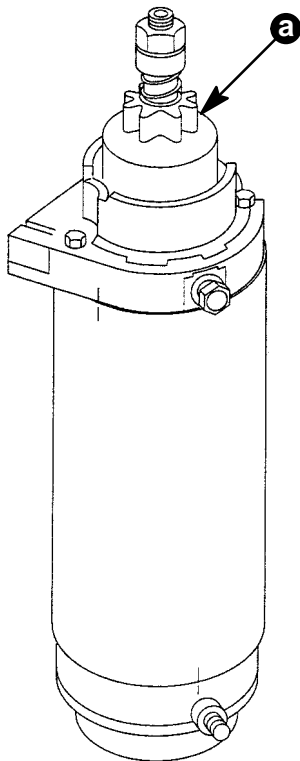
11648

With the starter removed, the starter pinion gear drive can be checked for slip. Hold the bottom of the drive assembly with a wrench and twist the pinion gear by hand. If the pinion gear turns by hand, it should be replaced because the rubber drive bond has failed.

a - Pinion Gear
