service bulletin

SmartCraft Communication Problem

Mercury/Mariner Outboards and Jet Drive engines connected to a SmartCraft Instrumentation system (SC 1000 System Tachometer, System Speedometer, System Monitor, or SC 5000 System View).

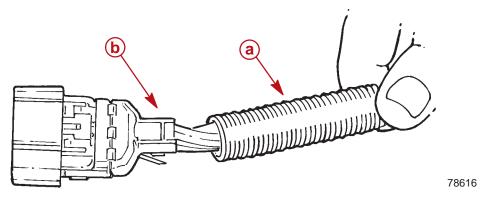
1. Slide the convoluted tubing away from the retainer. This will allow the retainer to open so wire placement can be checked.

- a Plastic Tubing
- **b** Retainer
- 2. Verify that the BLUE wire is in position K (corner position) and the WHITE wire is in position J.
 - If the BLUE wire is in position K and the WHITE wire is in position J, the wires were installed correctly. Close the retainer and push the convoluted tubing onto the retainer.
