service bulletin

☐ WARRANTY INFORMATION☐ PARTS INFORMATION	√ SEI	RVICE INFORMATIO	N Bul	letin No. 2002-18
Circulate to: Sales Manager A	Accounting	Service Manager	Technician	Parts Manager

Paint Wear

MST9205BF, MST9235BF

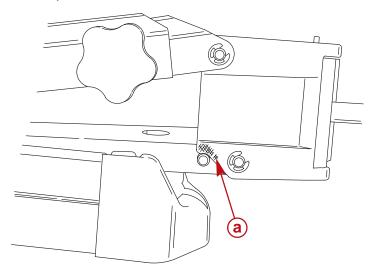
00299

If a 20.5 or 23.5 Gator Breakaway Bracket mount is in the stow position, the bolt head (MRK02503) will rub paint off of the bracket.

a - Paint wear

Replace with bracket of the new design.

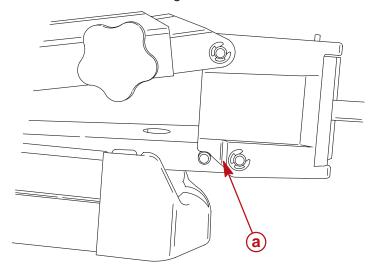
00300

a - Newly designed part

Qty: 1 MRK01108 (Black) MRK01109 (White)
