Bulletin No. 2003-03

Drum Coupling Wire Contact - Tour Edition SE motors

TR109P FB, TR109 FB, TR82P FB, TR82 FB

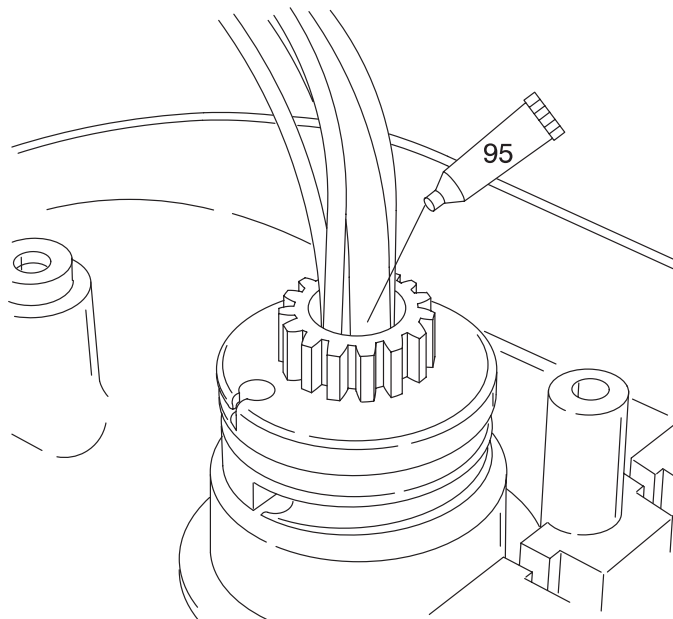
ob00771

The low current wires on Smart Electronic units may show signs of abrasion due to contact inside the drum control coupling located in the head unit.

In the control housing, remove the cable retainer. Lift the cable assembly off of the drum control coupling. Using a small brush, liberally apply lithium-based grease to the wires extending from the column. The grease application should extend ½" above and ½" below the bottom of the coupling. Reinstall the drum controller over the drum control coupling and secure the cables with the cable retainer.
