Top Housing Base Screw Torque Correction

Tour ES, Excel, Digital Steering, PTSv

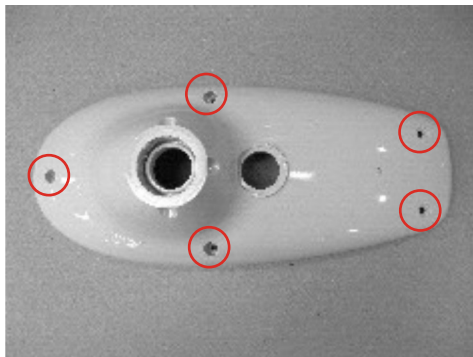
18574

Screws attaching the top housing cover to the top housing base have incorrect torque specifications in service manuals 90-MXC5900 and 90-MXC5901. The incorrect torque values can cause the top housing to be loose or to break.

The screws in the five illustrated locations must be tightened to 17 - 19 lb. in.

The top housing screws should be tightened to specifications.

Description	Nm	lb. in.	lb. ft.
Top housing screws (M00603)	1.92 - 2.15	17 - 19
