VariMAX Top Housing Replacement

MotorGuide has informed the MotorGuide service network of this issue (through MotorGuide Service Bulletin 2009-07) and they will have all the information needed to perform the necessary service work. MotorGuide will cover the costs of these repairs.

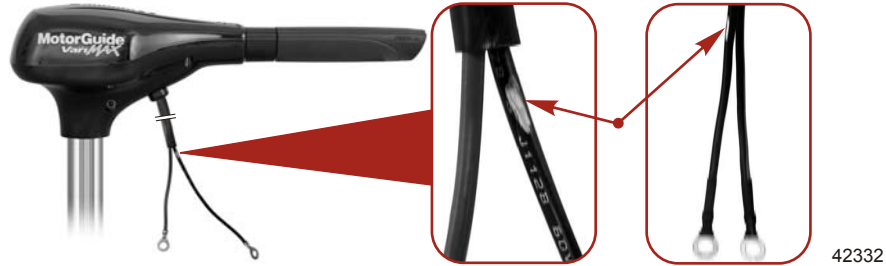
New, replacement top housings are available to address this issue. The new top housings are identified with a white mark on the black power cable as indicated in the following picture.

A white mark on the black power cable indicates a replacement top housing

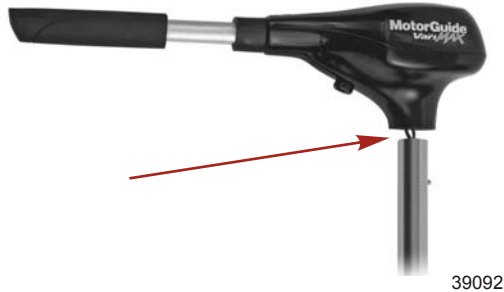
Top housing removed from column

- Remove the top housing from the column. Do not remove the heat-sink grease on the motor.

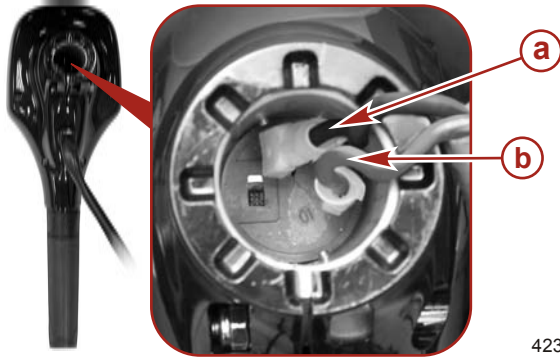
Motor control wires
a - Black motor lead
b - Red motor lead

4. Disconnect the motor control wires from the terminals.

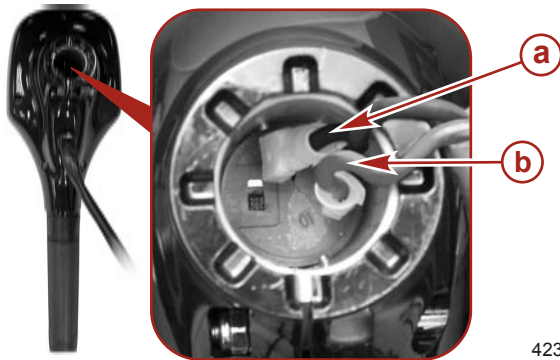
Transom mount motor configuration
a - Black motor lead
b - Red motor lead

2. With the top housing inverted, connect the motor control wires to the correct terminals as shown.

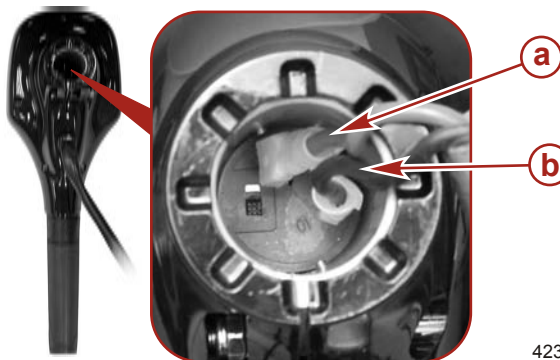
Bow or pontoon mount configuration
a - Red motor lead
b - Black motor lead
