WARRANTY INFORMATION SERVICE INFORMATION

Securing Trim Cylinders on Bravo Drives in Performance Applications

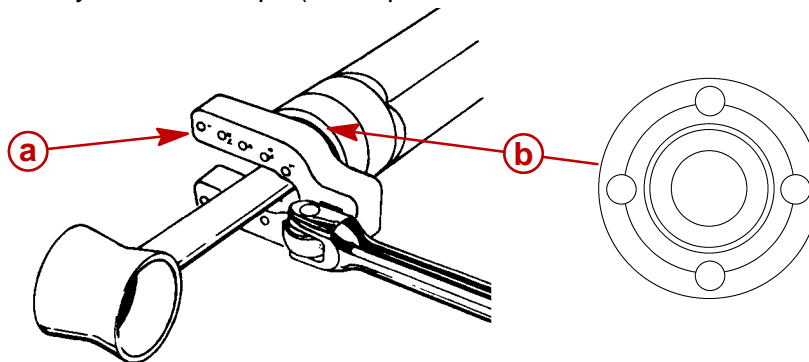
Trim cylinder end caps can loosen when the Bravo drive is installed at a high "X" dimension. This type of installation is usually done on high performance catamaran boats that have top speeds of 90 MPH plus.

- a** - Spanner Wrench Tool 91-821709T
b - End Cap Assembly

1. Remove both trim cylinders from drive unit.
2. Remove trim cylinder end caps (Use Spanner Wrench Tool 91-821709T).
