WARRANTY INFORMATION **SERVICE INFORMATION**

575 SCi Throttle Opening Adjustment

▲ = Revised September 2000

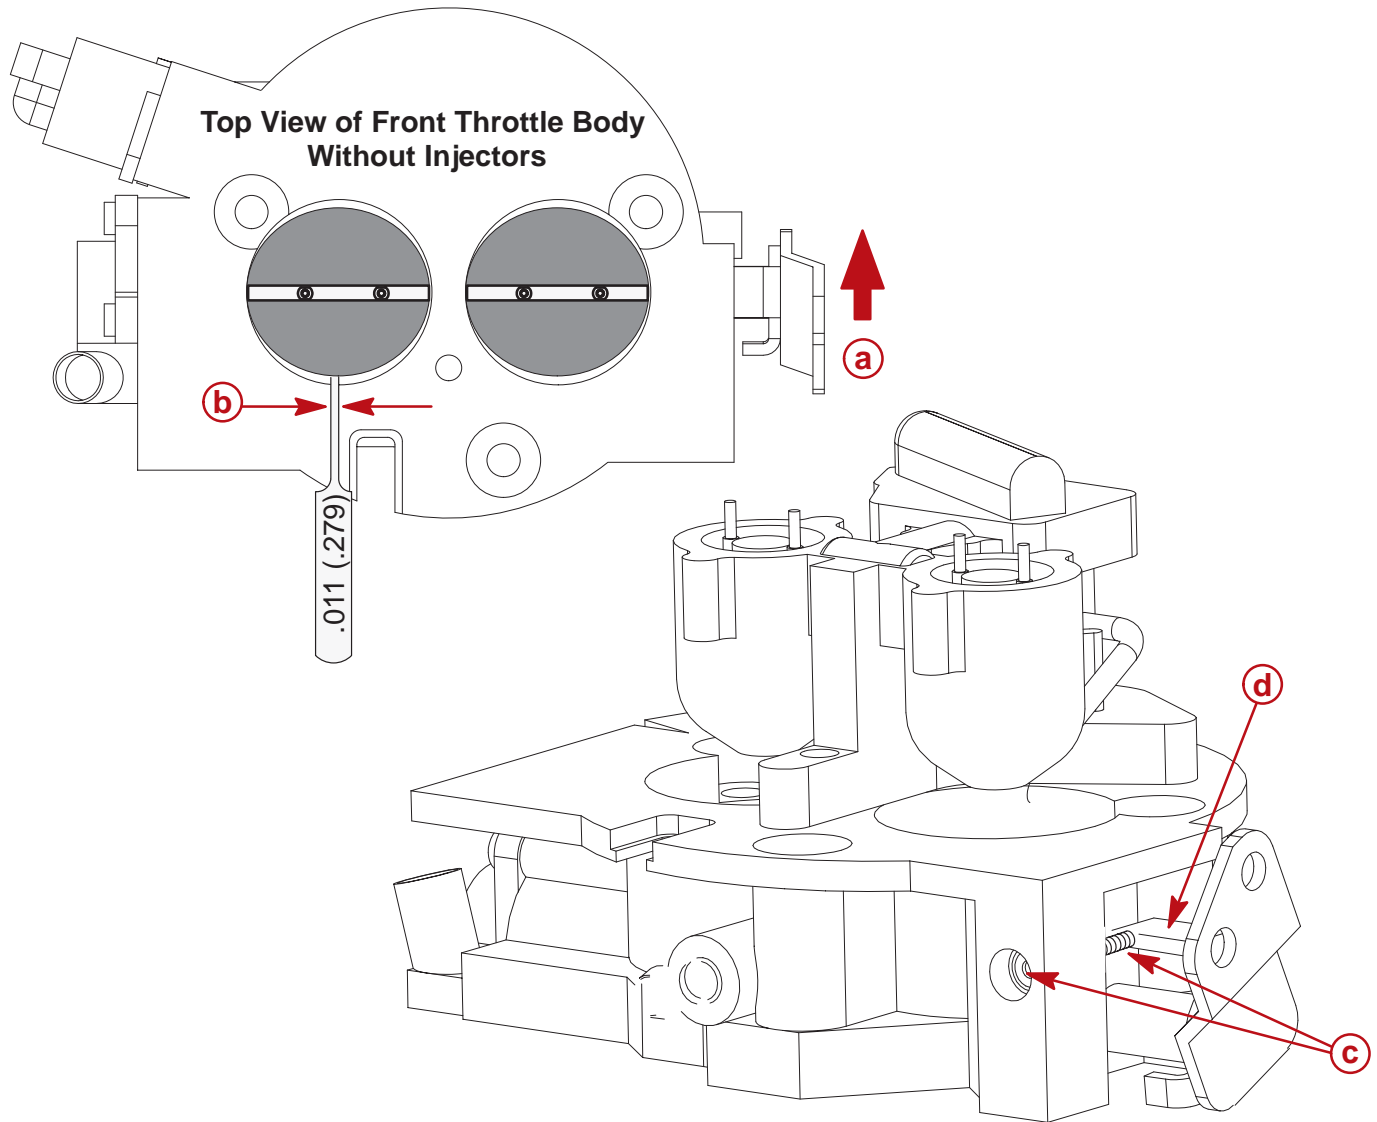
Engine stalls when put into gear. If using the Digital Diagnostic Tester (DDT) to check the Idle Air Control Follower (IAC) setting in neutral, the reading is at 100 plus counts.

- a** - Throttle Opening Direction
- b** - Maximum Blade Width 1/8" (0.125 mm)
- c** - Throttle Stop Screw (Adjust Front Throttle Body Only)
- d** - Throttle Lever (Should Make Contact with Throttle Stop Screw)

1. Disconnect throttle cable from cable end guide.
2. Remove flame arrestor.
3. ▲Use a modified 0.011 in. (0.279 mm) feeler gauge with a blade not wider than 1/8 in. (0.125 in. [3.175 mm]) to verify the throttle plate opening on the FRONT THROTTLE BODY ONLY. There should be drag on the feeler gauge for correct setting.
4. If adjustment is required, remove sealer that is covering access to the throttle stop screw and adjust screw to set gap at 0.011 in. (0.279 mm). Ensure that throttle lever contacts throttle stop screw.

5. With gap set and screw adjusted, fill in access to the throttle stop screw with silicone sealant. **This screw should never be used to adjust engine idle speed.**
