1100, 1350, 1550, and 1650 Battery Cable Routing

Models Covered	Serial Number or Year
1100, 1350, 1550, and 1650	All

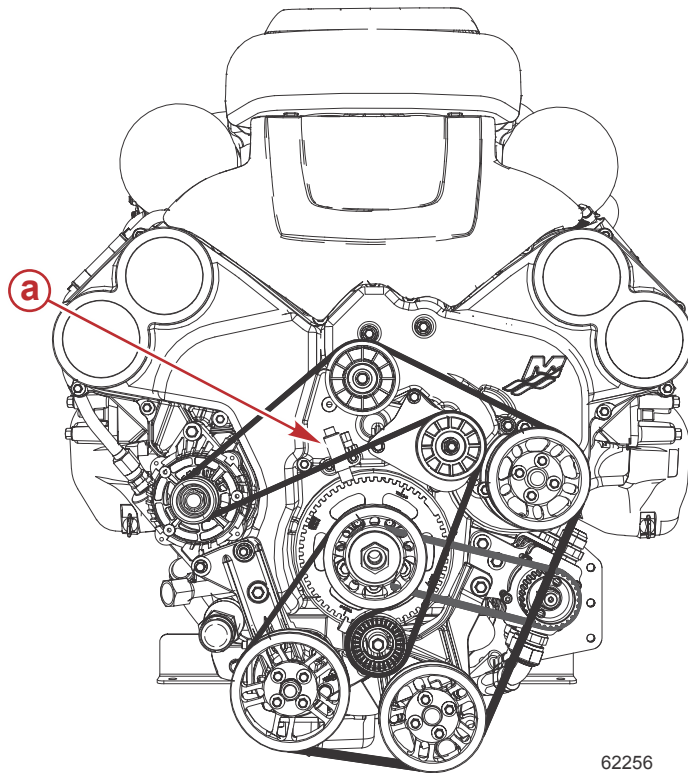
62256

An electromagnetic field is created when higher current passes through battery cables. If these cables are located too near the crankshaft position sensor, they will affect the sensor's signal and adversely affect engine performance. Therefore, engine battery cables and other cables carrying higher current such as alternator/isolator leads, trim pump, and auxiliary power must not be routed closer than 76.2 cm (30 in.) to the front of an 1100, 1350, 1550, or 1650 engine. Cables mounted closer than this to the crankshaft position sensor will result in engines failing to start or crank, misfiring, or performing poorly. The engine failing to crank may disengage before the Smart Start abort fault occurs.

Note that attaching a ground cable to the front of the engine will position it closer than the required minimum distance of 76.2 cm (30 in.) from the crankshaft position sensor, and will result in the engine failing to start, misfiring, and performing poorly.

a - Crankshaft position sensor

When diagnosing a running issue on a 1100, 1350, 1550, or 1650 engine, use the G3 tool to see if there is RPM with the key in the on position and not cranking, if so, the Smart Start thinks the engine is running. Observe the engine RPM while cranking and starting the adjacent engine. If an attempt is made to start the engine with false RPM, the Smart Start will stop the engine from cranking, normally within one crankshaft revolution. Ensure that both the positive and negative battery cables are at least 76.2 cm (30 in.) from the crankshaft position sensor or the front of the engine—ensure that the positive and negative battery cables are running adjacent to each other. Also, ensure that the battery ground bonding cable is attached to the rear of the engine on the ground stud and is at minimum the same gauge wire as used on the battery leads. Refer to the installation manual or service manual for identifying the proper location.

The negative and positive battery cables should be routed together (paired) when possible to balance and reduce the disruptive effects of either cable's electromagnetic field.
