Lower Driveshaft Bearing Installed Incorrectly – Verado and 3.0 Liter OptiMax Service Gearcase Assemblies

Models Affected

| Models Covered | Serial Number |
|---|---|
| 135/150/175/200 Verado L4 200/225/250/275/300 Verado L6 200/225/250 3.0 Liter OptiMax | Service replacement gearcases - See gearcase serial numbers listed under Part Identification . |

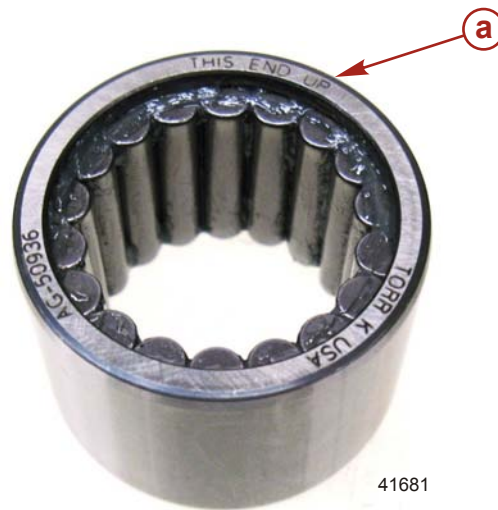
Some of the service gearcases listed below may have been assembled with the lower driveshaft needle bearing in the incorrect direction (number side down). Gearcases assembled in this manner will fail after a short time in operation. These service gearcases must be replaced and returned to Mercury Marine as soon as possible for inspection and possible rework.

a - This end up

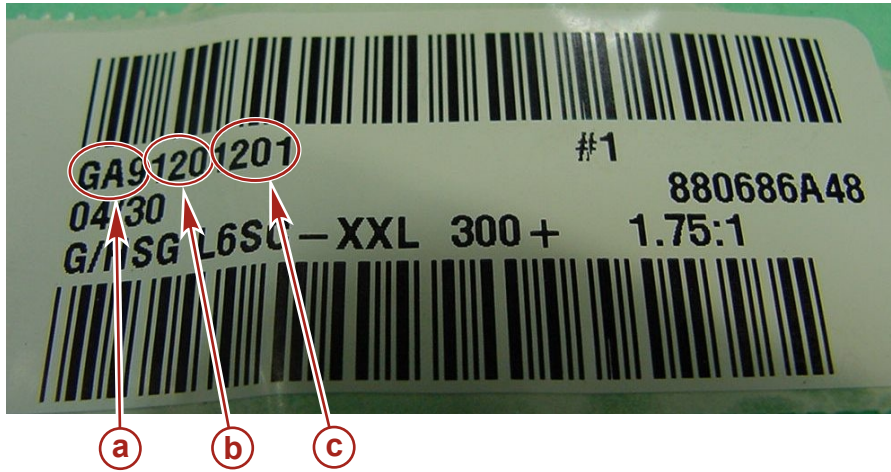
The table below shows the affected serial number codes. This code is found on the bar code sticker affixed to the top side of the anti-ventilation plate. Gearcase replacement is only required if the gearcase serial number can be matched with one of the suspect serial numbers listed.

- a** - Assembly line
- b** - Julian date
- c** - Time stamp: First engine at 12:00 hour

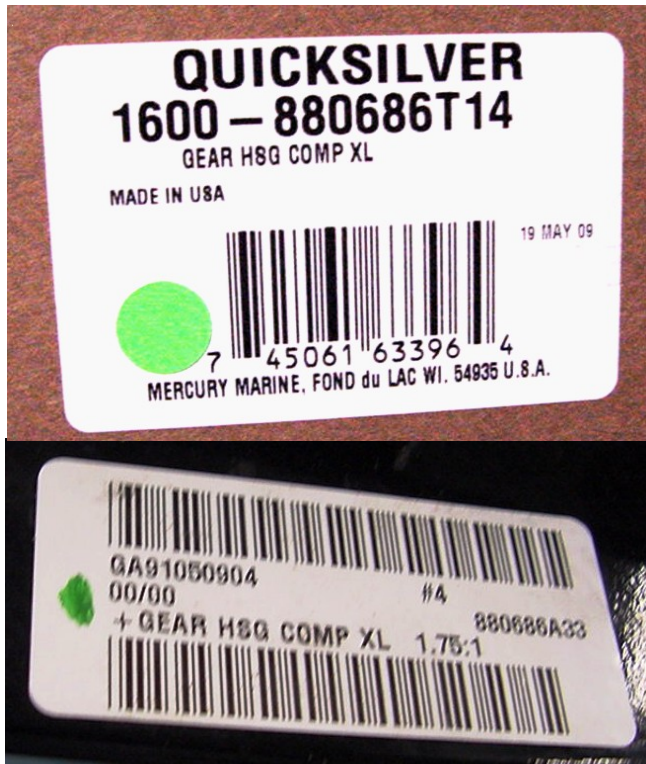
41685

Service gearcases within the serial number range listed that have been inspected or reworked at Mercury Marine are identified by:

- A green paint mark on the end of the propeller shaft.
- A green paint mark applied onto the serial number label located on the gearcase anti-ventilation plate.

- A green dot sticker applied to the part number label on the gearcase shipping carton.
