B. MerCathode Electrode and Anode Installations

E. Vented Top Cover Seal - MerCruiser 120-140-160 Models

E. VENTED TOP COVER SEAL - MerCruiser 120-140-160 Models

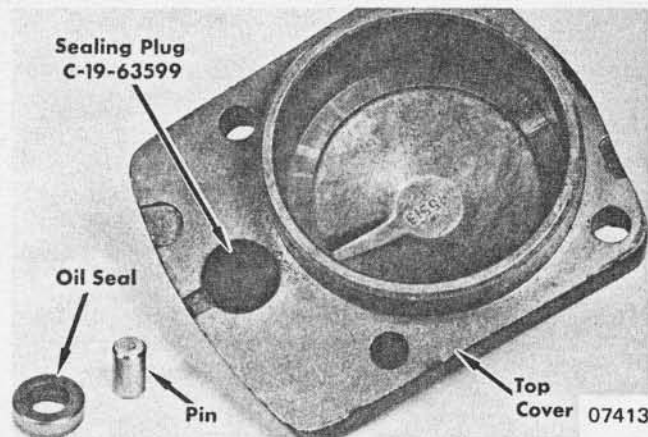
Figure 1. Sealing Plug Installed

MerCruiser 120 and 140 Stern Drives (Serial No. 2062141 thru 2266775) and 160 Stern Drives (Serial No. 2065190 thru 2269838) were built with vented top cover assemblies.

Whenever these drives are serviced, we recommend removing the oil seal and pin from the cover and installing new sealing plug C-19-63599. (Figure 1)

C-19-63599

Sealing Plug, Top Cover
