Zeus Midsection Plate Corrosion Repair

ZEUS HH, IH, & JH PODS

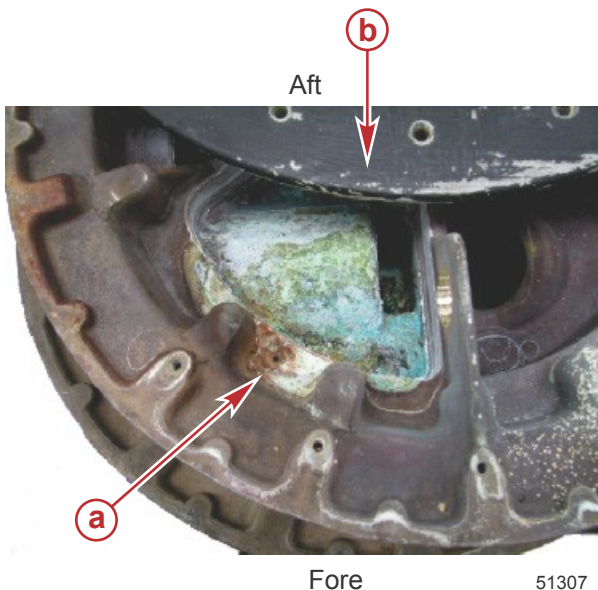
In some applications, minor pinholes or pitting corrosion may occur on the midsection plate near the MerCathode anode assembly. When this occurs, a putty repair kit is available for repairing the bronze midsection plate.

In other applications, if only heavy green/blue corrosion exists in the cavity as shown below, further corrosion can be prevented by installing a new anode assembly. A new MerCathode backing plate and screws should also be installed.

The following photo highlights the area of the midsection plate that could be affected.

View from below with the seawater intake cover removed

- a** - Corroded area with pinhole
- b** - Seawater intake cover removed

If minor pinholes or pitting corrosion is found, then only the putty repair kit (8M0074256) must be utilized.

If corrosion is evident with no pinholes or pitting (green/blue colors,) the anode assembly kit (8M0074249) and the MerCathode backing plate and screws (8M8025265) should be installed.

Repair procedure is included in the putty repair kit.
