NUMBER: 84-8

- A. 1984 Model 18XD and 25XD Equipped with Tiller Handle Harness and Start Button Assembly, 87-95810A2
- B. Tiller Handle Inspection/Rework - Models 35/40/50
- C. New Service Tools Available
- D. Torquing of V-6 Cylinder Head Bolts
- E. Timing Pickup Change - V-200 S/N 6537933 and Above

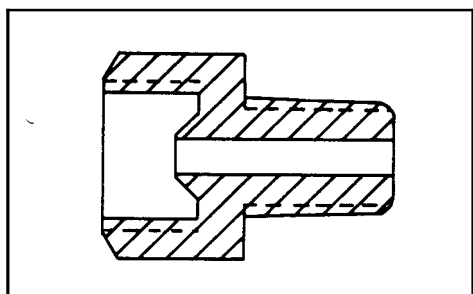
Figure 3.

22-11243 Connector, Figure 3, used to adapt Power Trim Test Gauge, 91-52915A3 for checking pressure in the 1984 Model 75/90/115 Power Trim System. (Figure 4) 91-11230 Guide Tool - Lower Shaft, Figure 5. This tool is used as a guide to install the shaft into Power Trim manifold on 1984 Model 75/90/115 with Power Trim. (Figure 6)
