ADVISORY
 BULLETIN

No. 2001-06

Official Notification Federal Boat Safety Act Flywheel Nut Retorque - 115 EFI Four Stroke

2001 115 EFI Four Stroke

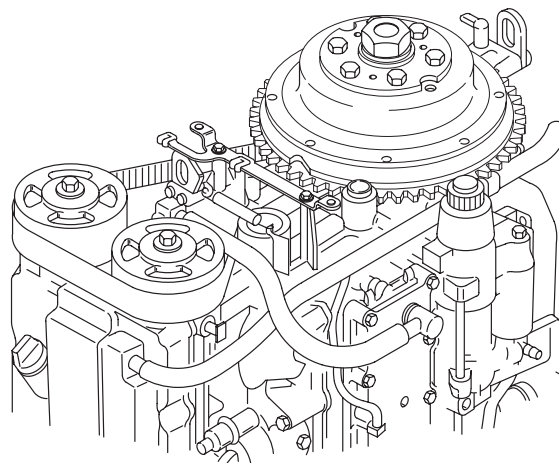
57601

Mercury Marine Inventory – Inventory has been reworked and marked with a yellow line across the end of the crankshaft and flywheel nut surface. A yellow dot is also placed on the starter motor housing.

Outboards with yellow marks have been reworked at Mercury Marine and do not require the retorque.

The retorquing of the flywheel nut should be performed as soon as possible on units in service, before start up of units returning to service, and before start up of a new unit. The proper procedure is described in this bulletin.
