## Electric Fuel Pump Harness Connection

### Models Affected

Mercury/Mariner Models	Serial Number or Year
135/150/175 HP OptiMax	S/N 0T776014 thru 0T790902 Model Year 2003

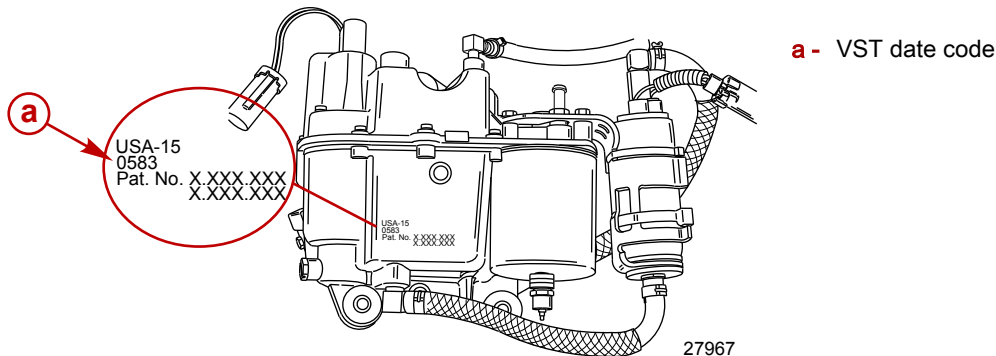
### Affected VST Date Codes

0563, 0573, 0583, 0593, 0623, 0633, 0643, 0763, 0773, and 0783

Not all pumps on the above listed models will be affected. The low pressure electric fuel pump is part of the Vapor Separator Tank (VST) assembly when installed at the factory. First inspect the VST for affected date codes (listed below). If the date code on the VST is NOT listed below, no further action is required. If the VST does have one of the affected date codes, perform the following electric fuel pump terminal inspection.

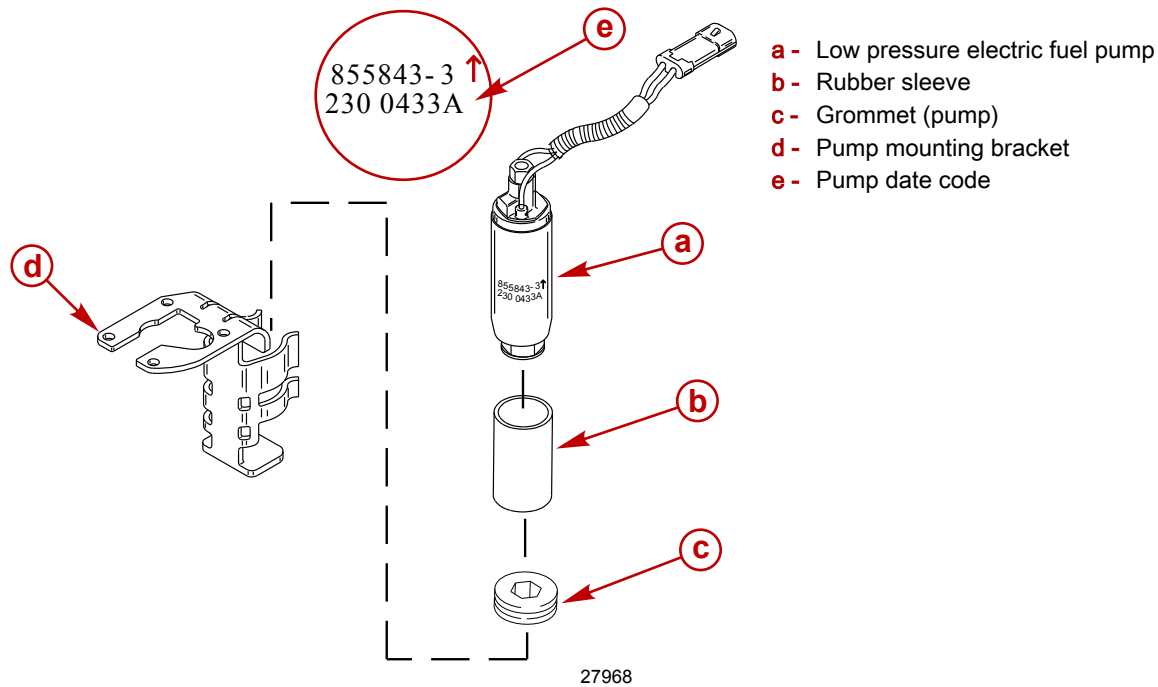
Any low pressure electric fuel pumps (P/N 855843 2) in dealer service inventory that has a packaging date between March 1, 2003 and April 28, 2003 should be inspected for affected pump date code and/or terminal crimp condition. Only pumps with date code 0433A are affected. NO other date codes are affected. Remove rubber sleeve from the pump to view date code. If the date code is NOT 0433A, no further action is required. If the pump date code is 0433A, perform the wire terminal inspection as outlined in this service bulletin.
