Official Recall Notification U.S. Federal Boat Safety Act - Power Steering Tilt Helm

Mercury Marine has learned that there may be an issue with certain tilt steering mechanisms. The retaining pin for the steering knuckle may be loose which may result in a loss of steering. As a result, a Federal Boat Safety Act Recall of the at risk tilt steering mechanisms is being conducted. Because the recall is not focused on engines, there is no engine serial number range to exactly identify the product that requires the recall. As a result, at risk units must be identified by an inspection of the products that might contain the issue.

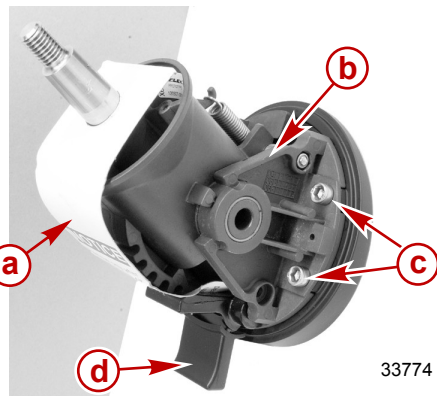
33774

- a - Notice tag - remove after installation
- b - Tilt mechanism
- c - Screw (M6 x 16) (4)
- d - Tilt tab - face down

If the unit is within the affected date range and no green dot is present, replace the tilt mechanism with part number 8M0073155 which includes the tilt helm, fasteners, and the instruction sheet.

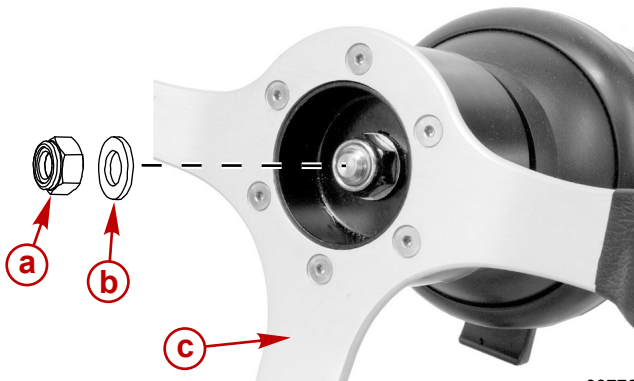
33776

- a - Locknut (19 mm hex)
- b - Flat washer
- c - Steering wheel
