4.5L Sterndrive Engine Flame Arrestor Clamp

Models Affected

| Models Covered | Serial Number Or Year |
|---|---|
| All Sterndrive 4.5L Engines | 2A441953–2A446695 |

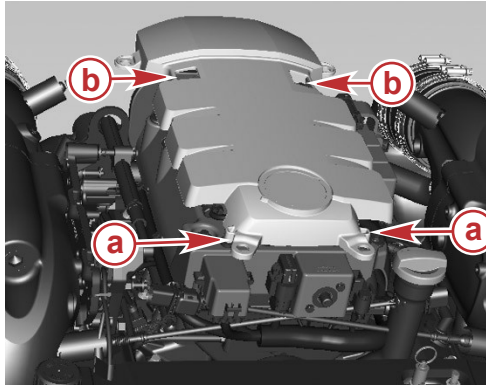
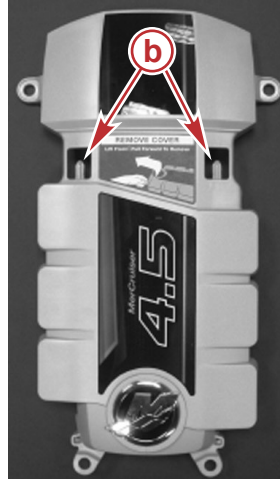
54984

- a - Front grommets
b - Rear grommets

- b. Lift up on the front of the second cover to disengage the cover from the front grommets. Pull the cover towards the front of the vessel to remove it from the two rear grommets.
