## Rocker Arm Replacement Required

Models Covered	Serial Number Or Year
8.2L EC and Non-EC Sterndrive and Inboard	Refer to the <b>Serial Numbers Affected</b> table at the end of this bulletin.

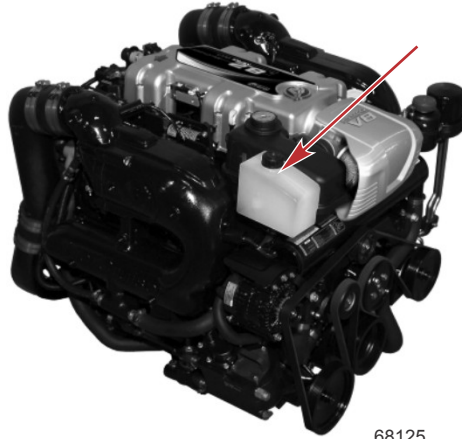
68125

**Gear lube bottle**

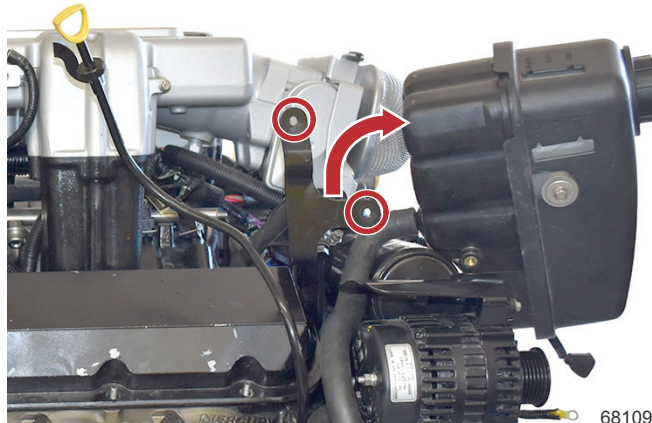
68109

- d. Disconnect the oxygen sensors, if equipped, and the EMCT sensors.
- e. Remove the valve cover attaching nuts.
- f. Remove the port side valve cover.
- g. Remove the starboard side valve cover as follows:
  - Disconnect the three screws for the coolant reservoir on the starboard side of the engine, and tip the reservoir forward, as shown. The third screw is on the back side of the reservoir, not shown in the image.

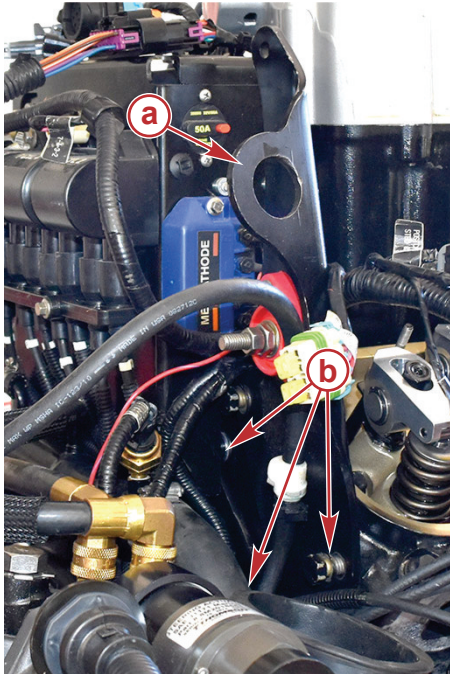
68130

- Loosen the three bolts securing the rear lifting eye/hot stud bracket to the cylinder head. Slide the bracket toward the rear of the engine, to allow clearance for removal of the valve cover.

- a - Rear lifting eye/hot stud bracket
- b - Bolts (3)

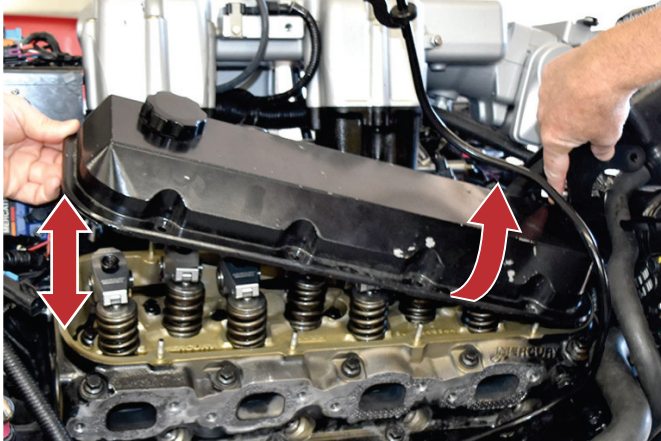
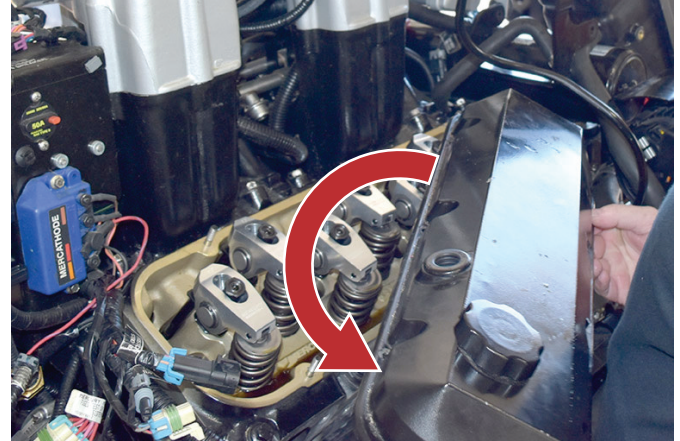
68111

- Elevate the rear of the valve cover 10.2–12.7 mm (4–5 in.), as shown.
- Pivot the front side of the valve cover inward, then downward to free the cover from between the front valve cover studs and the coolant reservoir and drive lube bottle mounting bracket.
- Rotate the valve cover outward and lift the cover up and off of the engine.
