No. 92-9

A. ENGINE ALIGNMENT TOOL MODIFICATION

All Alpha One Gen II Models

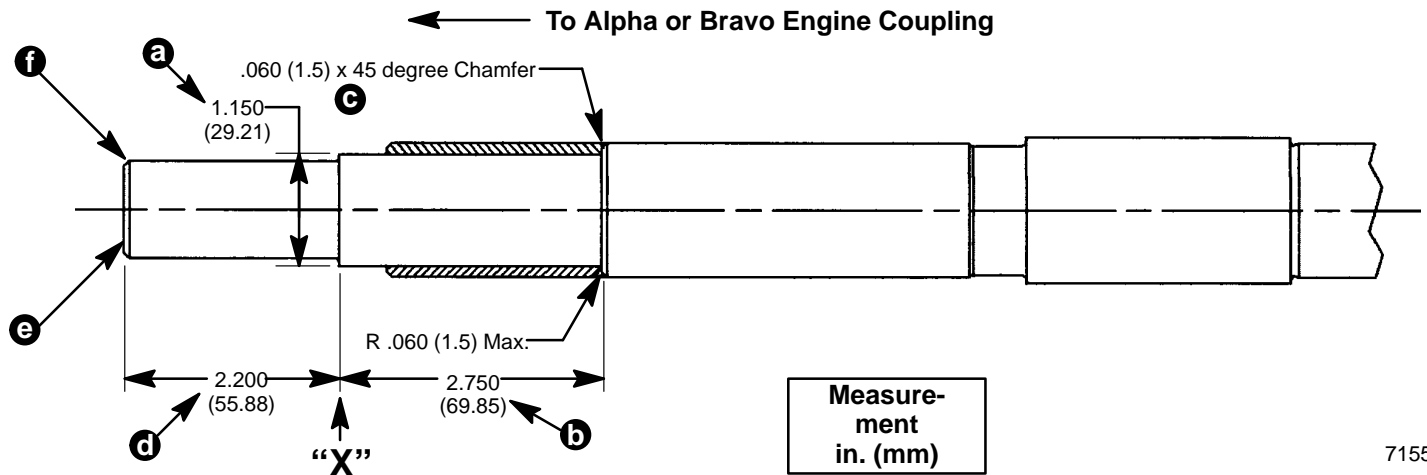
Figure 1.

An engine coupler change will take place on these model engines sometime in August, 1992. Because of this change, the current Alignment Tool (91-57797A3) will not properly align the engine. Please have your current alignment tool modified as shown in Figure 1 or order a new alignment tool.

Use the first step on the tool as reference point "X".

- 1) The shaded area of the tool must be machined off. Machine the 1.150 in. (29.21mm) diameter (a) back for a total of 2.750 in. (69.85mm) (b) from reference point "X". Finish the edge of the new step as shown by (c).
- 2) Measure from reference point "X" to the end of the tool. This should not be longer than 2.200 in. (55.88mm) (d). If the step is longer, remove material from the end (e) until the step is 2.200 in. long. If material was removed, put a .060 in. (1.5mm) x 45 degree chamfer on edge (f).

The modified 91-57797A3 tool or the new tool 91-805475A1 will align all current Alpha One or Bravo models as well as all older engines that used the older 91-57797A3 tool.
